Inventory and Assessment of Municipal Street Light Assets

Assessment Report

Prepared for:
Municipality of Middlesex Centre

December 15, 2023

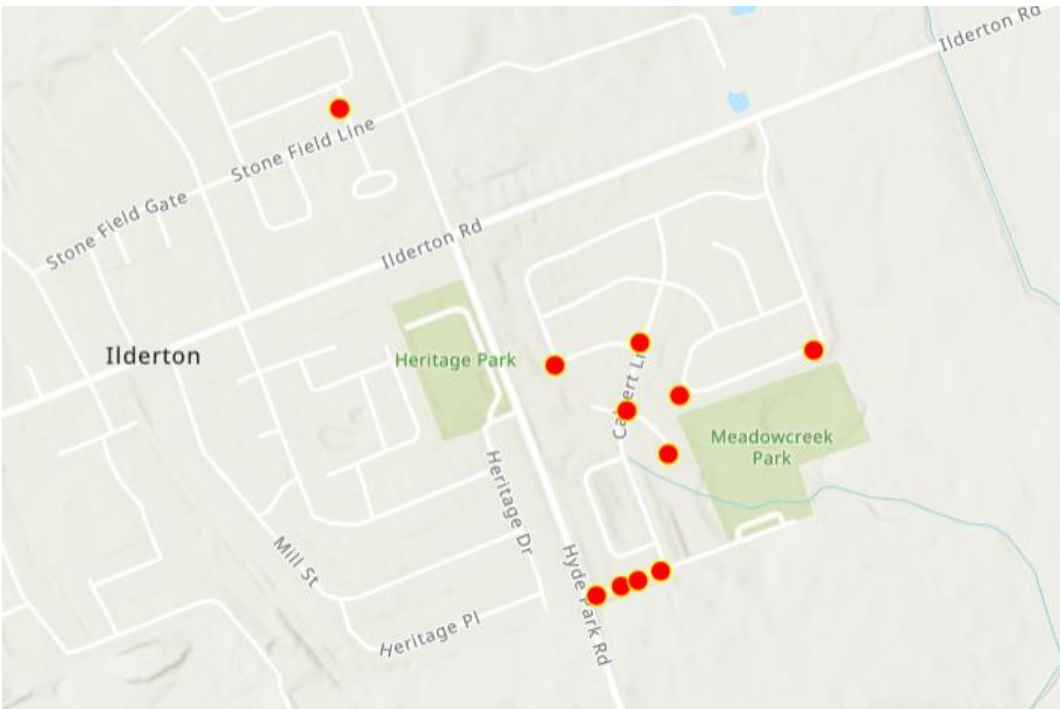
Of the 14 missing pole handholes, 11 are in Ilderton, and 3 are in Komoka-Kilworth. Snippets may be found below for reference to the noted locations. More detailed locations can be found in the GIS package circulated to the Municipality.

Figure 1: Pole Handhole Cover Missing - Ilderton

1. Immediate maintenance for missing and damaged Municipal pole handholes, and replacement of missing arm attachment bolts, combined 78 locations.
2. Maintenance and potential replacement of pole, arm, and luminaires with poor conditions at approximately 125 locations.

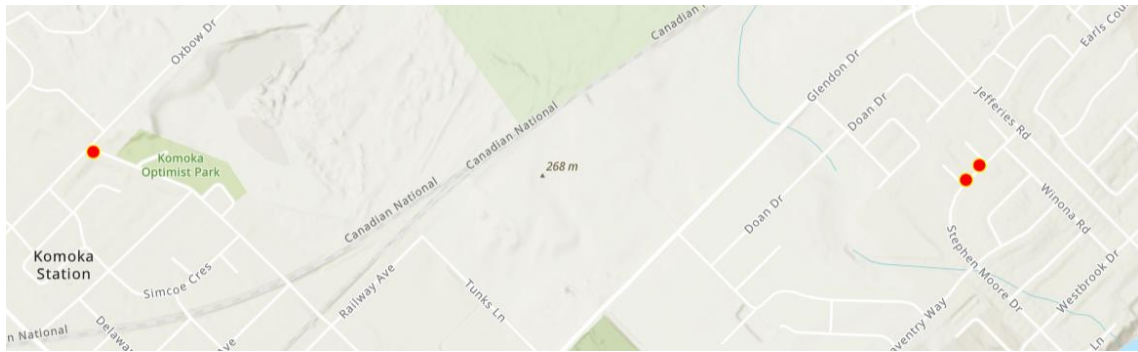
Figure 2: Pole Handhole Cover Missing – Komoka-Kilworth

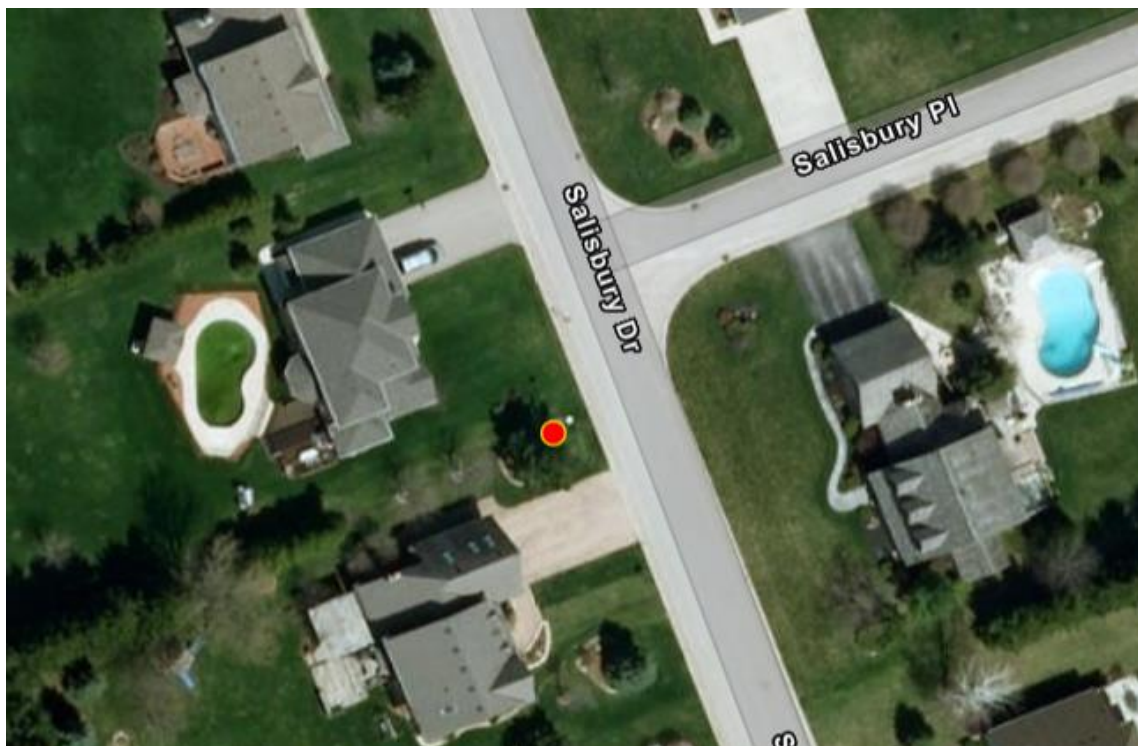
- 1 is in Birr.
- 10 is in Delaware.
- 37 is in Ilderton.
- 16 is in Komoka-Kilworth.

Figure 3: Pole Handhole Cover Damaged - Birr

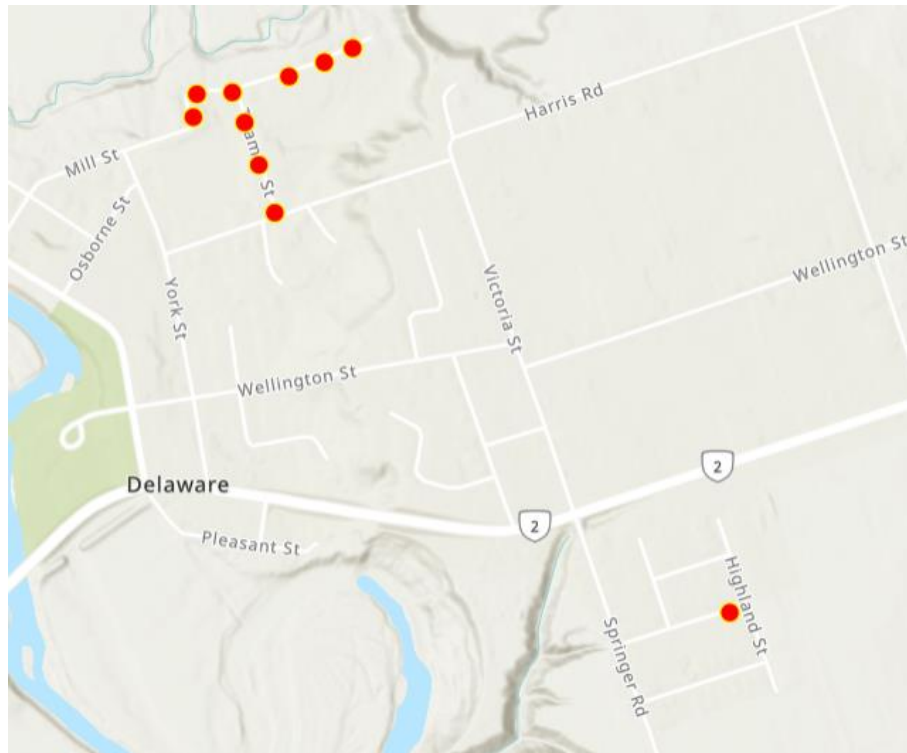
Figure 4: Pole Handhole Cover Damaged - Delaware

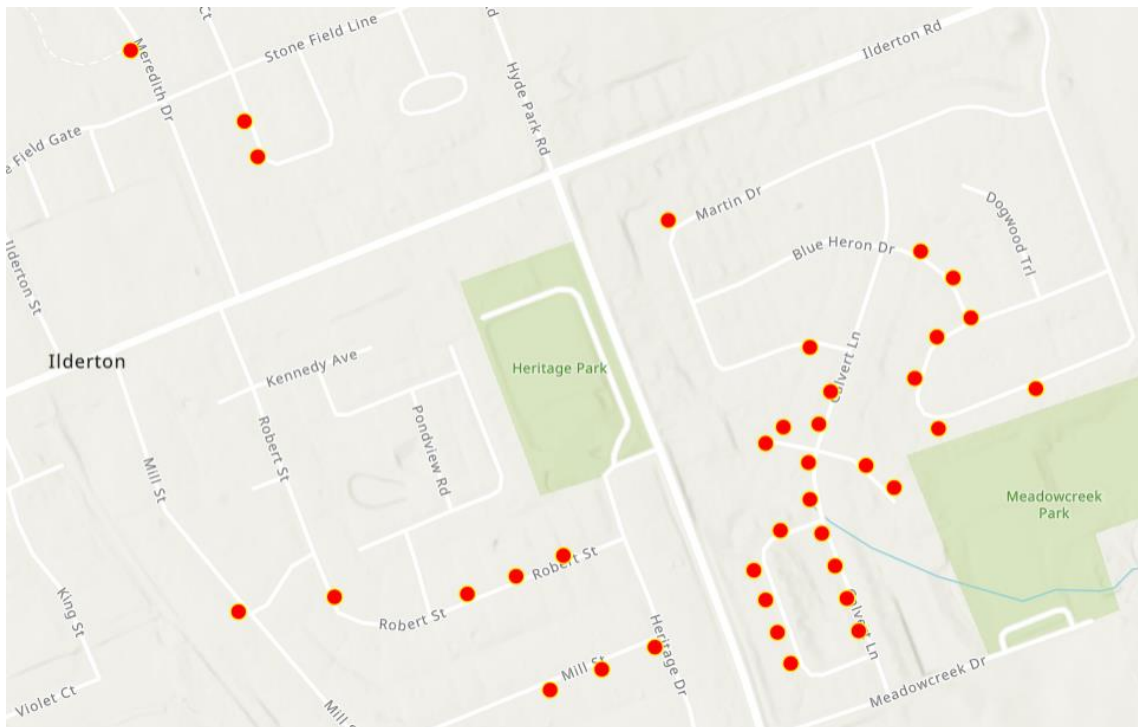
Figure 5: Pole Handhole Cover Damaged - Ilderton

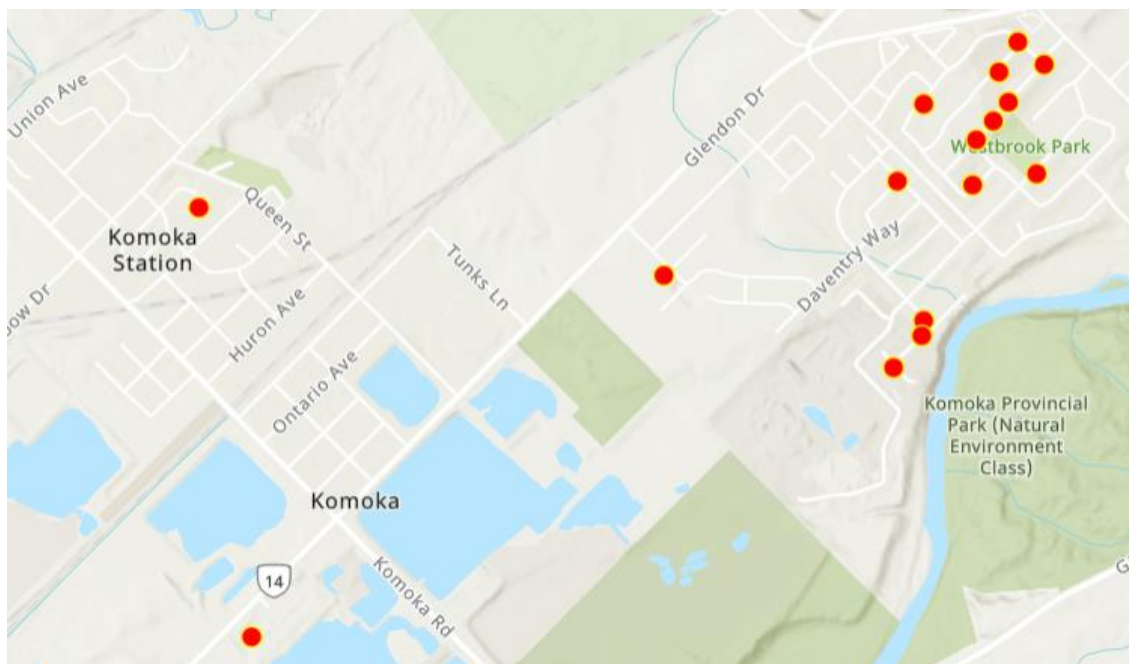
Figure 6: Pole Handhole Cover Damaged - Komoka-Kilworth

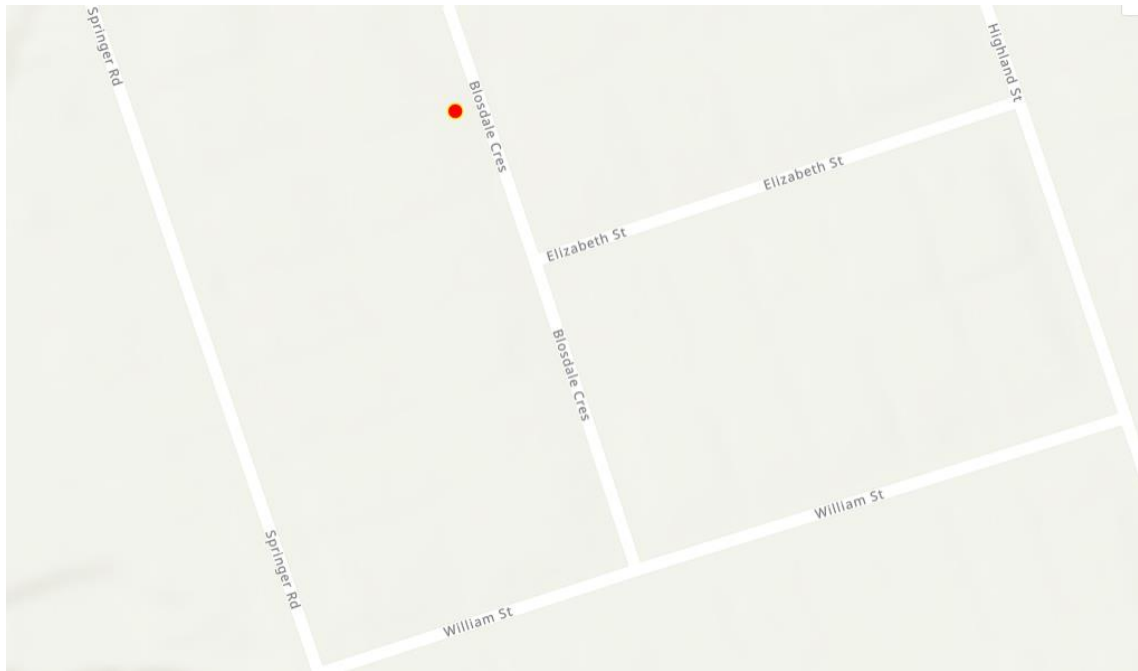
Figure 7: Bolt Missing - Delaware

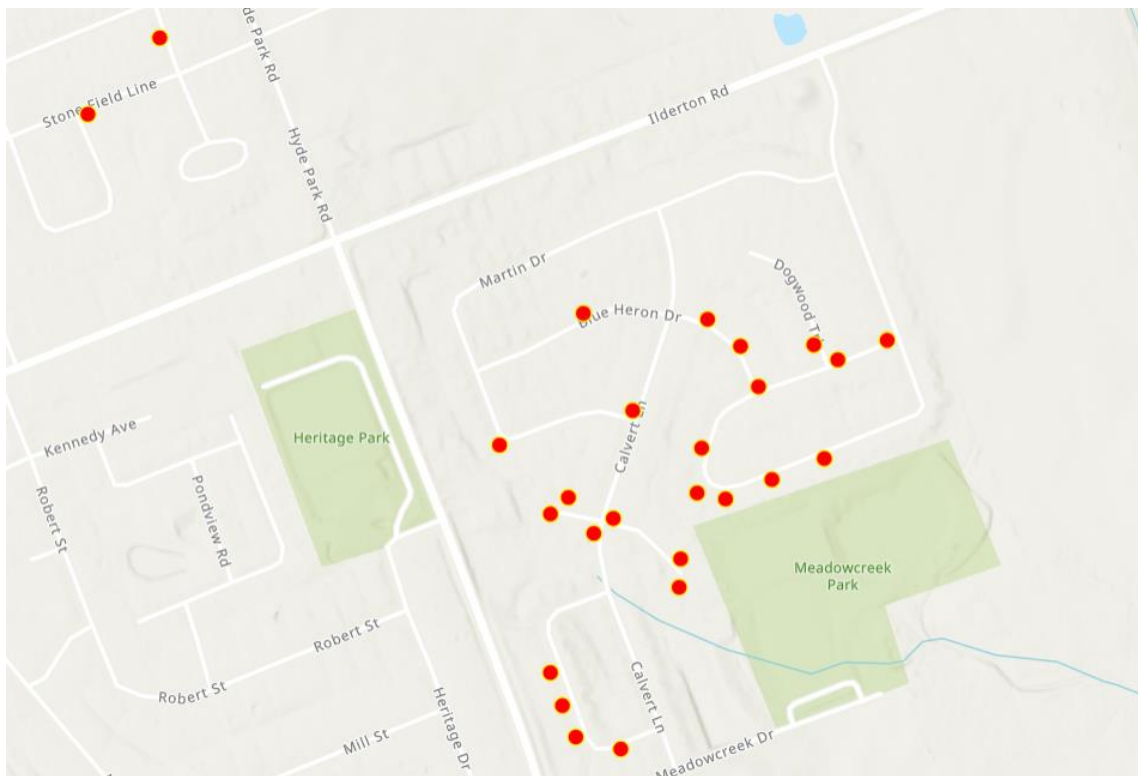
Figure 8: Bolt Missing - Ilderton

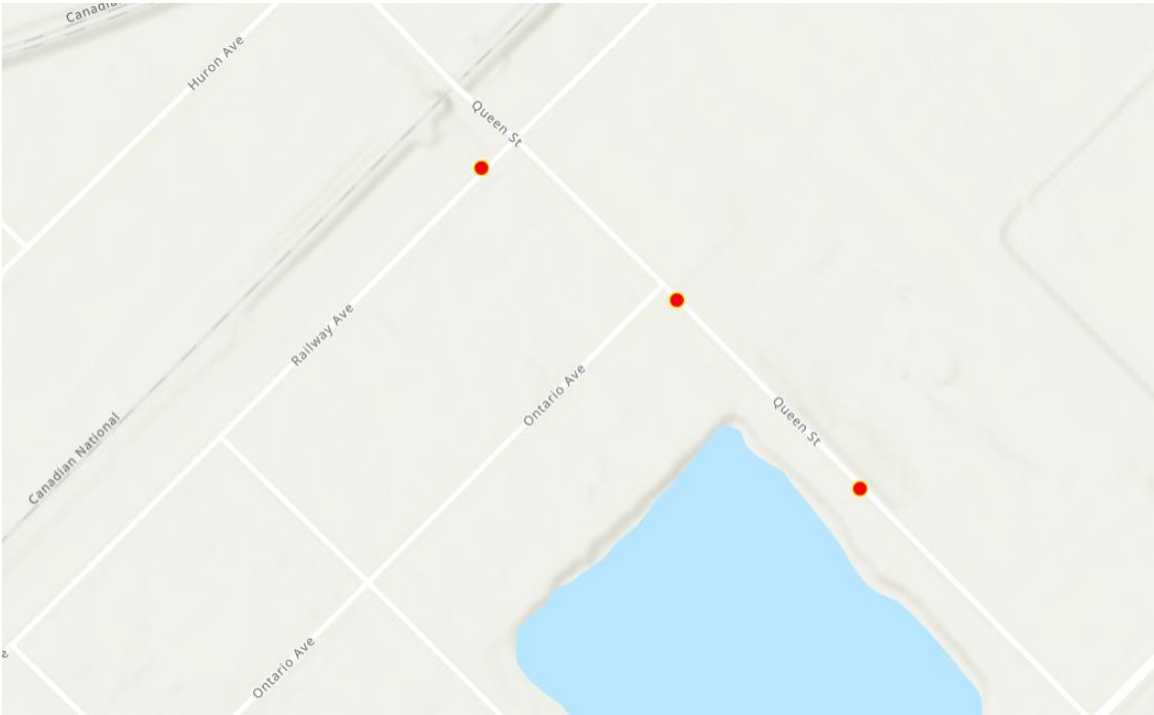
Figure 9: Bolt Missing - Komoka-Kilworth

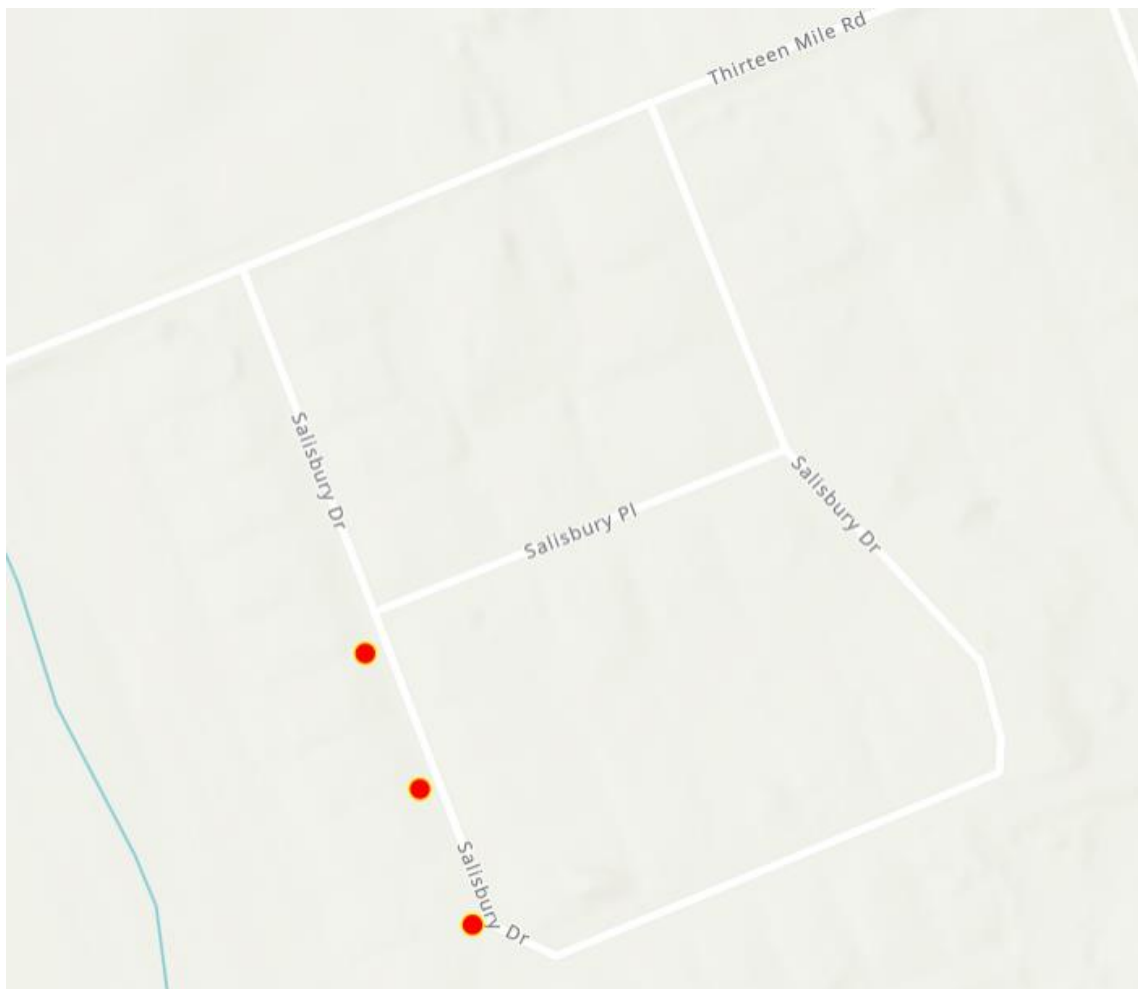
In the pole review, an indication of poor was noted for scenarios where the pole was not plumb, was rusted, had cracks, or had a visual damage.

Figure 10: Pole Condition Poor - Birr

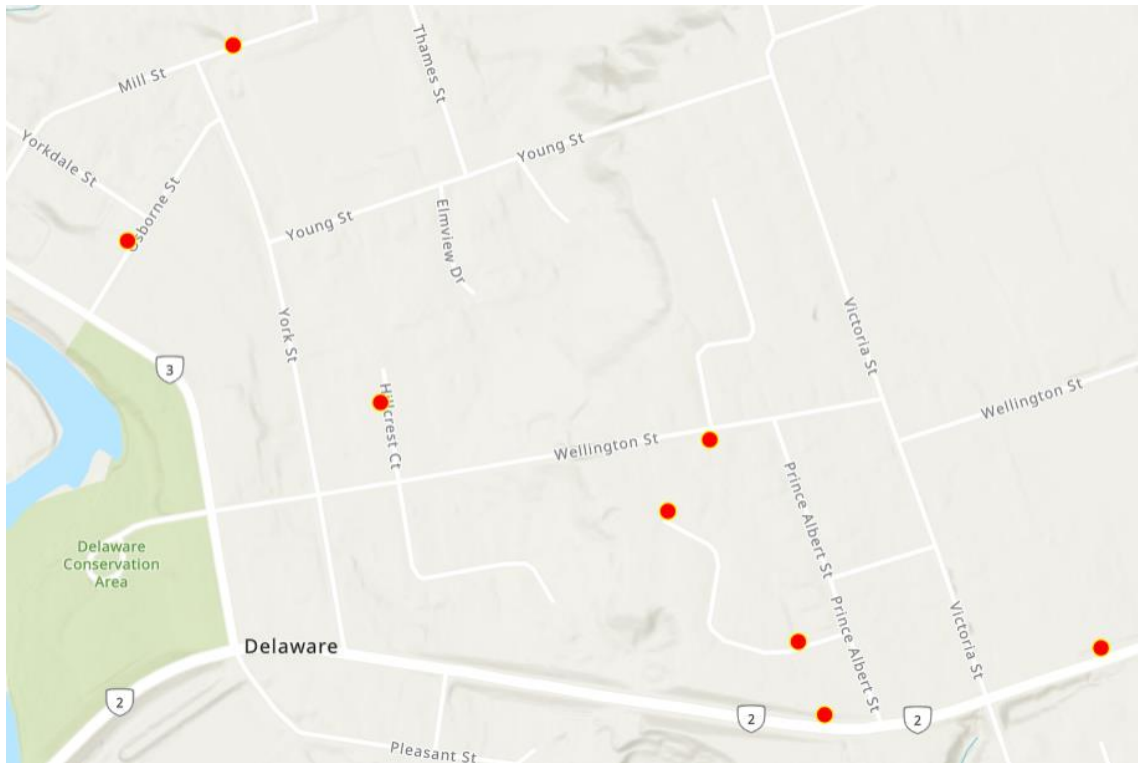
Figure 11: Pole Condition Poor - Delaware

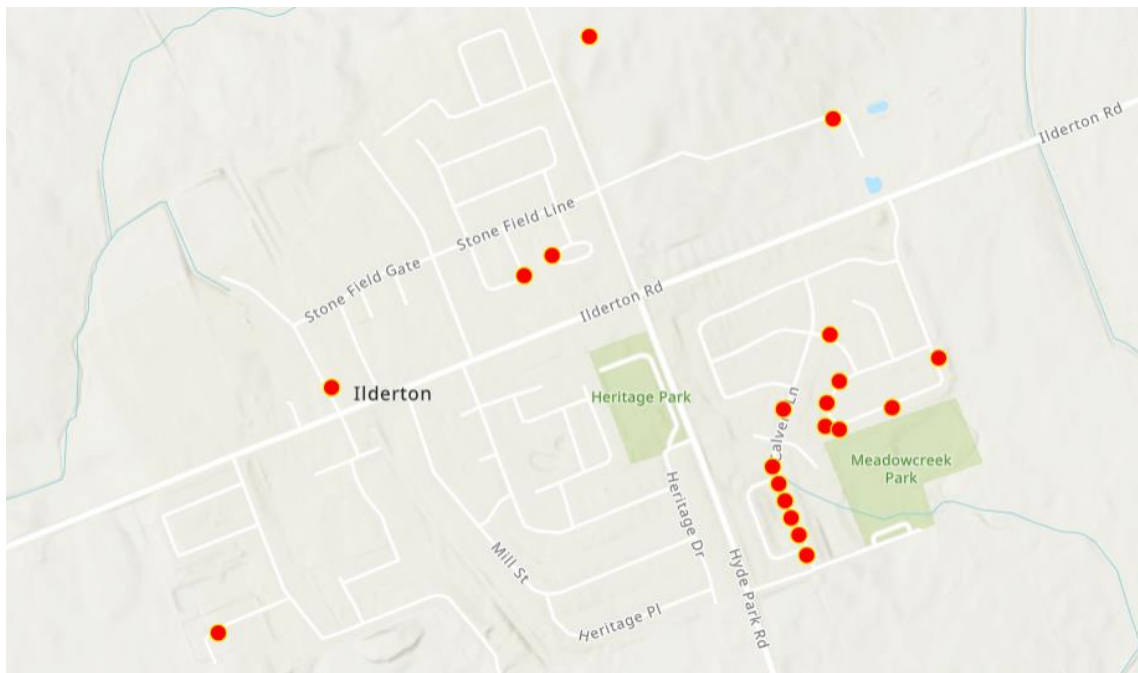
Figure 12: Pole Condition Poor - Ilderton

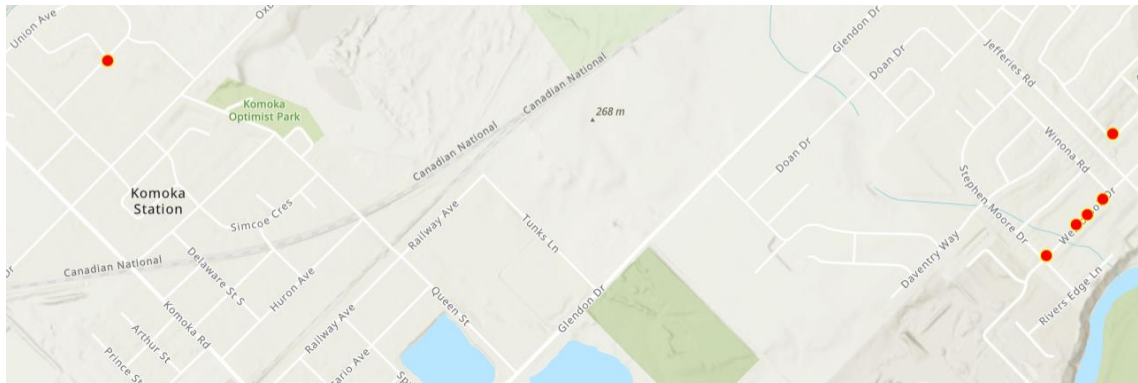
Figure 13: Pole Condition Poor - Komoka-Kilworth

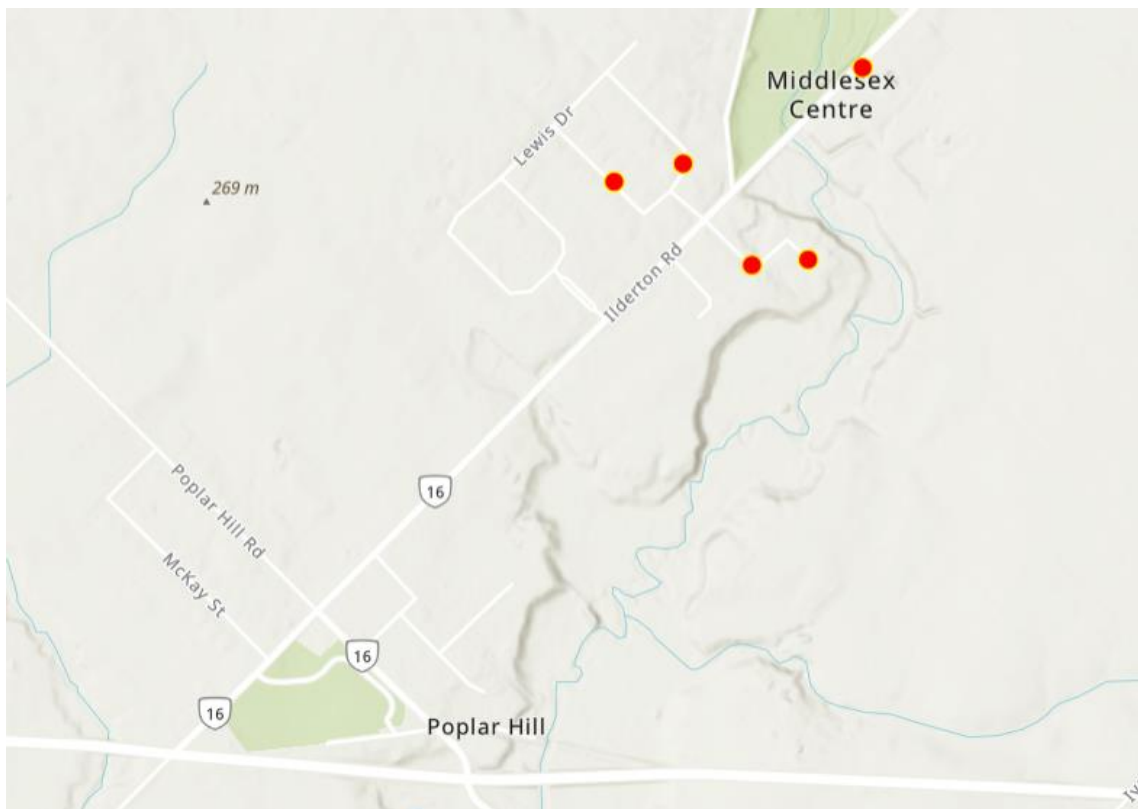
Figure 14: Pole Condition Poor - Poplar Hill / Coldstream

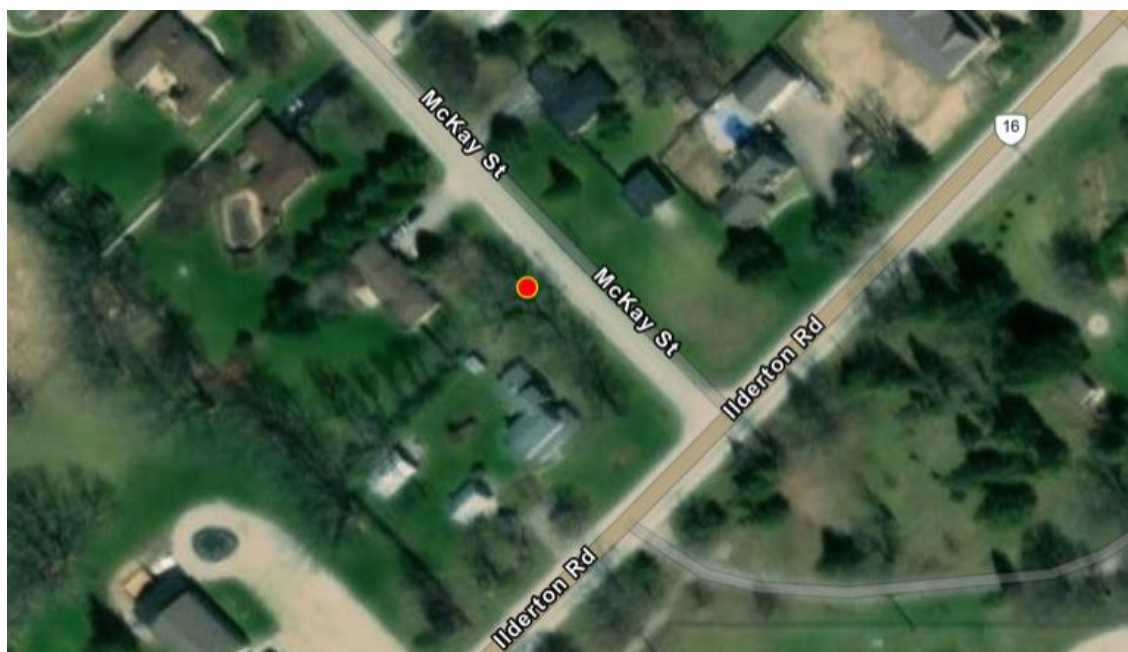
In the arm review, an indication of poor was noted for scenarios where the arm was rusted, or bolts were damaged.

Figure 15: Arm Condition Poor - Poplar Hill / Coldstream

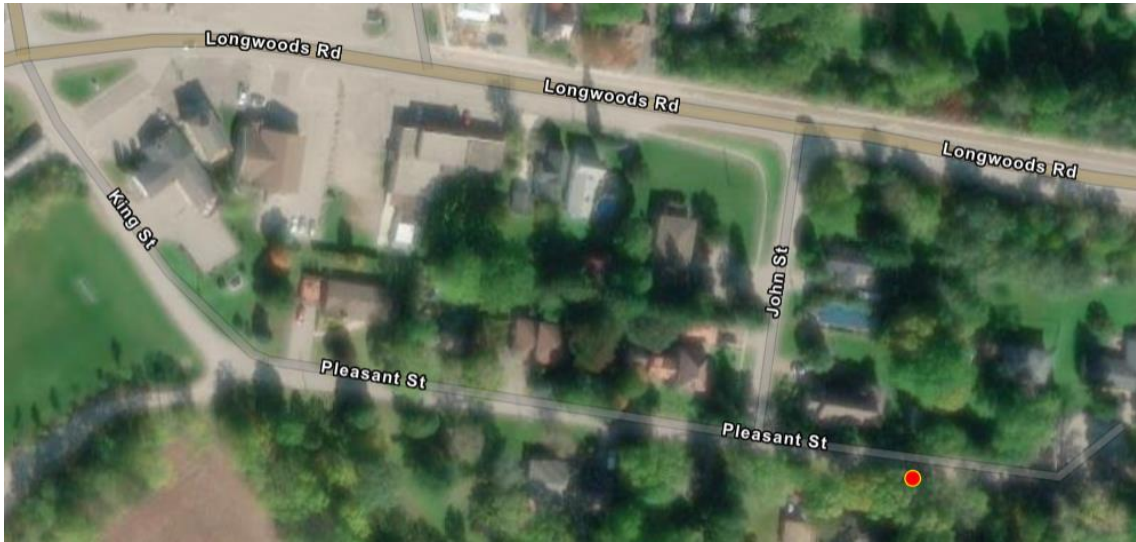
Figure 16: Arm Condition Poor - Delaware

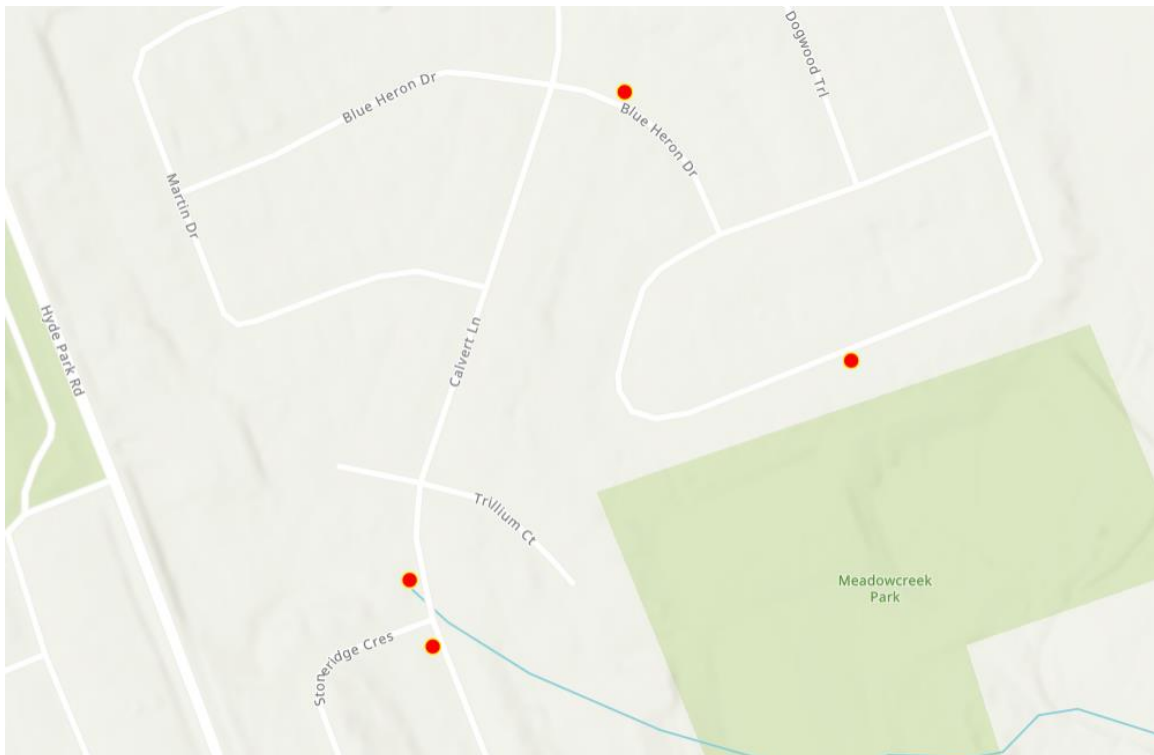
Figure 17: Arm Condition Poor - Ilderton

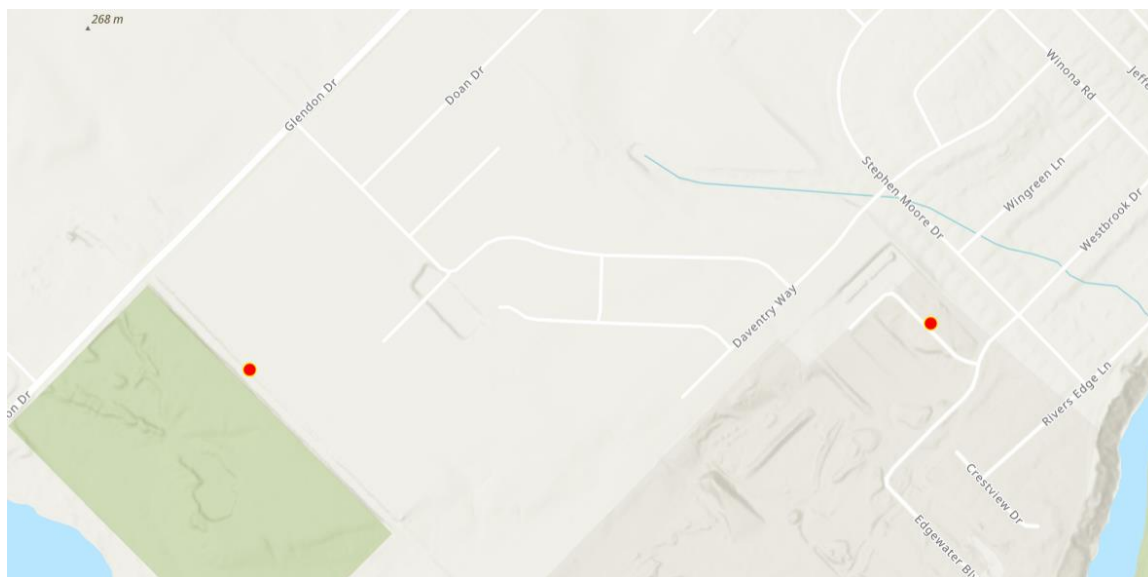
Figure 18: Arm Condition Poor - Komoka-Kilworth

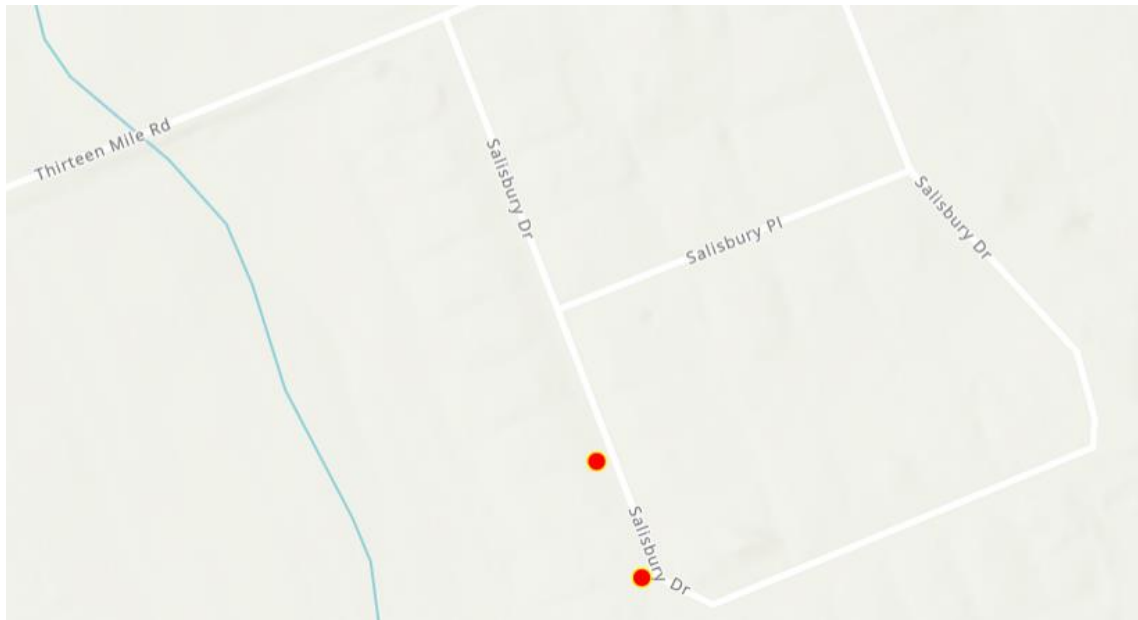
In the luminaire review, an indication of poor was noted for scenarios where the luminaire was rusted, covered by a treeline, LEDs covered in dirt, or has a loose attachment on the arm.

Figure 19: Luminaire Condition Poor - Birr

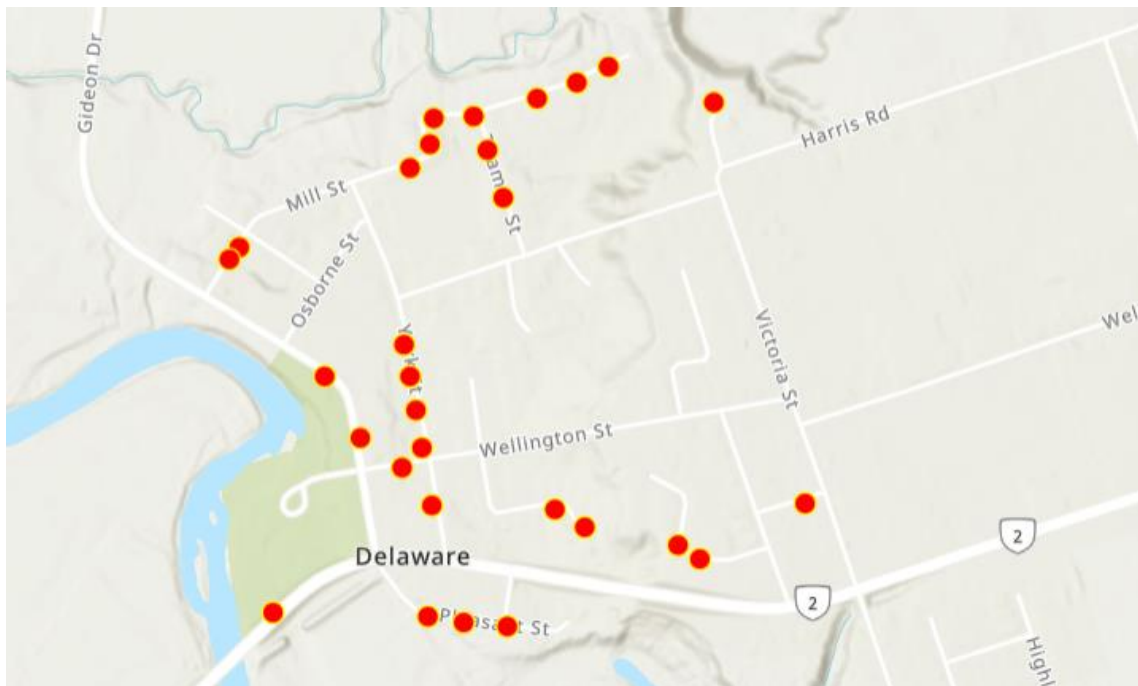
Figure 20: Luminaire Condition Poor - Delaware

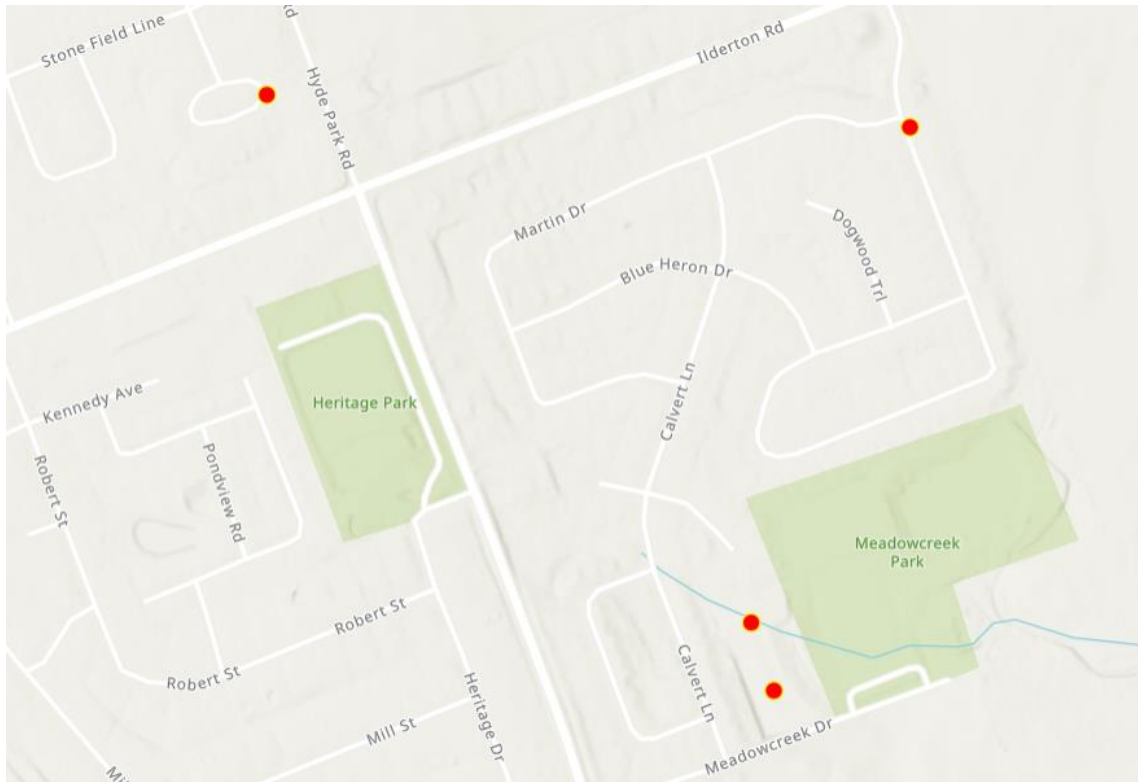
Figure 21: Luminaire Condition Poor - Ilderton

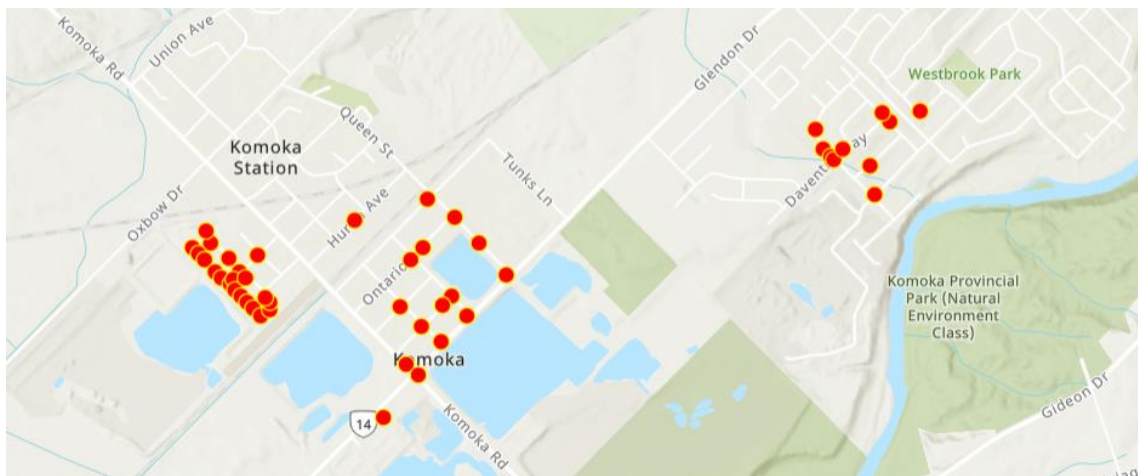
Figure 22: Luminaire Condition Poor - Komoka-Kilworth

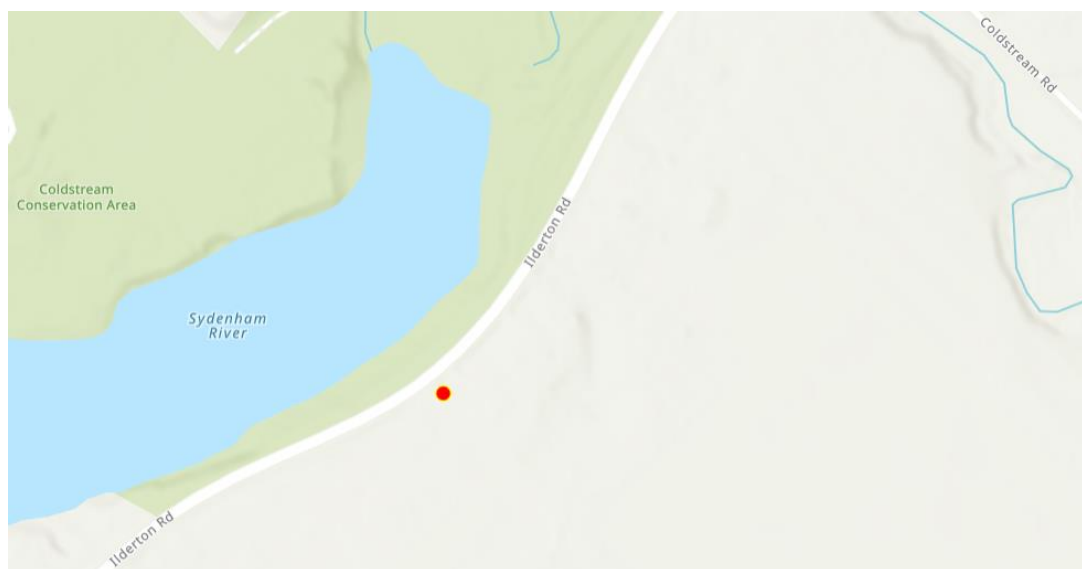
Figure 23: Luminaire Condition Poor - Poplar Hill / Coldstream
