PLAYGROUND INSPECTION REPORT

Site Location Address: Bryanston School Park - 15237 Thirteen Mile Rd, Bryanston, Ontario, N0M 2A0

Report: Annual comprehensive

Date: March 25th, 2025

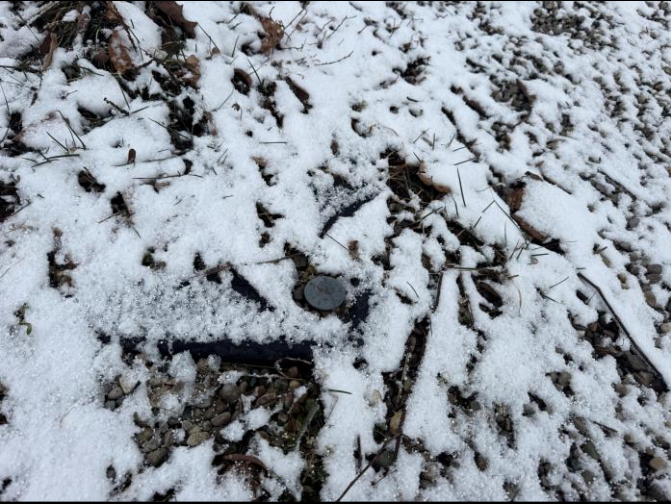
<table><tr><td>Clause</td><td>3</td></tr><tr><td colspan="2"><i>Trip Hazard - An abrupt change in elevation that is not clear and obvious to the user.</i></td></tr><tr><td>Priority # 3</td><td></td></tr><tr><td colspan="2">Poly retainer (adjacent to swing set) - Sections of poly retainer present at swing set creating a trip hazard.</td></tr><tr><td colspan="2">RECOMMENDED ACTION: Remove remaining sections of the poly retainer.</td></tr></table>	Clause	3	<i>Trip Hazard - An abrupt change in elevation that is not clear and obvious to the user.</i>		Priority # 3		Poly retainer (adjacent to swing set) - Sections of poly retainer present at swing set creating a trip hazard.		RECOMMENDED ACTION: Remove remaining sections of the poly retainer.	
Clause	3										
<i>Trip Hazard - An abrupt change in elevation that is not clear and obvious to the user.</i>											
Priority # 3											
Poly retainer (adjacent to swing set) - Sections of poly retainer present at swing set creating a trip hazard.

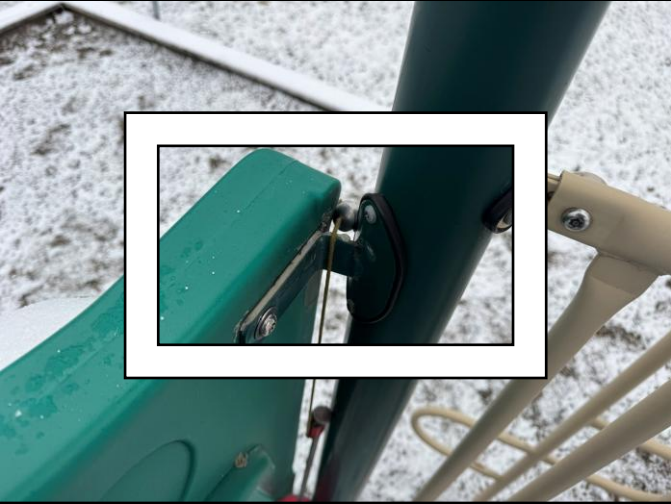
<table><tr><td>Clause</td><td>12.4.1</td></tr><tr><td colspan="2"><i>In areas of uncontrolled motion(eg., slide or sliding pole) there shall be no entanglement hazards that can entangle drawstrings or other clothing.</i></td></tr><tr><td>Priority # 1</td><td></td></tr><tr><td colspan="2">Dual slide (95cm platform) left side - Toggle/cord of testing device caught between slide and platform.</td></tr><tr><td colspan="2">RECOMMENDED ACTION: Install silicone, caulking or mouldable glue (or similar) to prevent the cord/toggle from becoming caught.</td></tr></table>	Clause	12.4.1	<i>In areas of uncontrolled motion(eg., slide or sliding pole) there shall be no entanglement hazards that can entangle drawstrings or other clothing.</i>		Priority # 1		Dual slide (95cm platform) left side - Toggle/cord of testing device caught between slide and platform.		RECOMMENDED ACTION: Install silicone, caulking or mouldable glue (or similar) to prevent the cord/toggle from becoming caught.

Clause	12.4.1										
<i>In areas of uncontrolled motion(eg., slide or sliding pole) there shall be no entanglement hazards that can entangle drawstrings or other clothing.</i>											
Priority # 1											
Dual slide (95cm platform) left side - Toggle/cord of testing device caught between slide and platform.											
RECOMMENDED ACTION: Install silicone, caulking or mouldable glue (or similar) to prevent the cord/toggle from becoming caught.

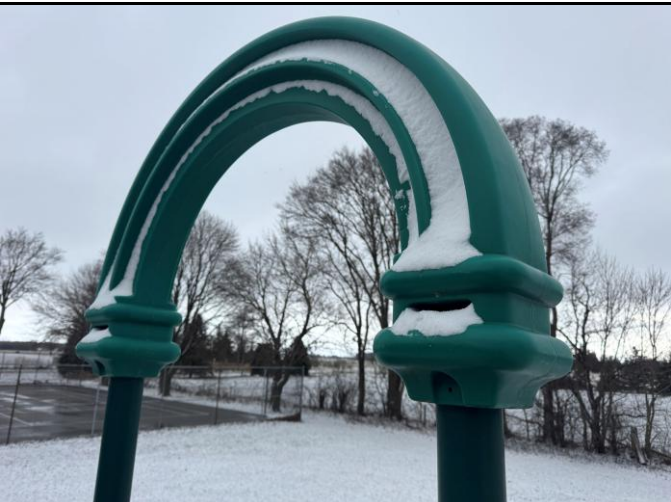
<p>Clause 7.8.1 <i>Fastesners, connecting, and convering devices shall not loosen or shall not be removable without the use of tools. Lock washers, self-locking nuts, or other locking means shall be provided for all nuts and bolts. Hardware in moving joints shall also be secured from unintentional loosening.</i></p> <p>Priority # 3</p> <p>Countertop panel - Loose hardware.</p> <p>RECOMMENDED ACTION: Tighten the hardware as soon as possible.</p>

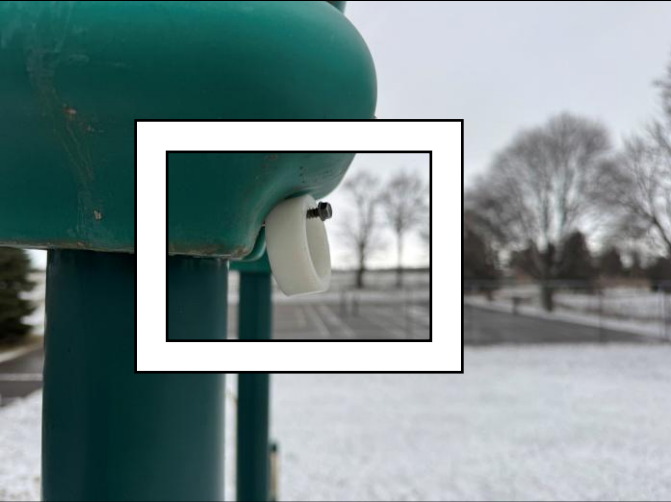
<p>Clause 11.4.1 <i>All repairs shall comply with this Standard. When a defect is observed, it shall be immediately reported and repaired. Details of the defect or problem and remedial action shall be recorded. If the repair takes time, all reasonable steps shall be taken to restrict access. Warning or danger signs alone shall not be acceptable. Damaged or worn components shall be repaired or replaced in accordance with this Standard.</i></p> <p>Priority # 1</p> <p>Poly arch component (above wave slide 130cm platform) - Missing hardware.</p> <p>RECOMMENDED ACTION: Contact the manufacturer to obtain the correct hardware for this component. Replace hardware as soon as possible.</p>

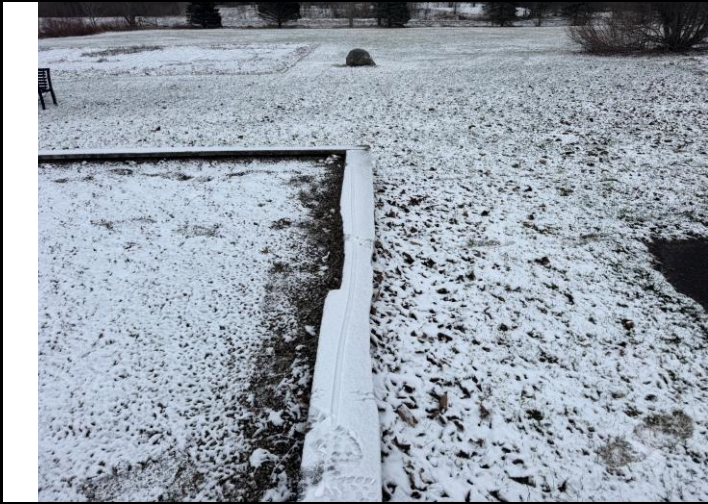
Wood retainer

The wood retainer was demonstrating minor signs of deterioration at the time of inspection.

The wood retainer is not covered by the requirements of CSA Z614, however good practice suggests repairing damaged/deteriorating components as required to prevent the risk of equipment failure or injury to users.

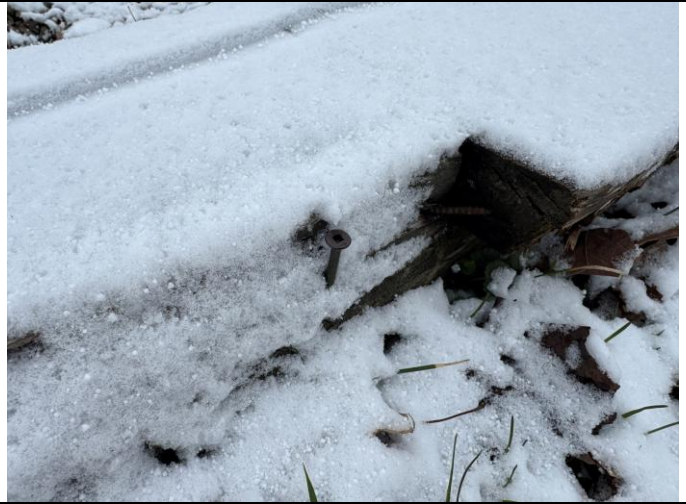
Poly retainer

Sections of a poly retainer were present at the time of inspection (adjacent to swing set).

It appears that some sections of the retainer have been removed while other sections remain.

Though the retainer is not covered by the Standard, it is recommended that the remaining sections of poly retainer be removed as soon as possible.

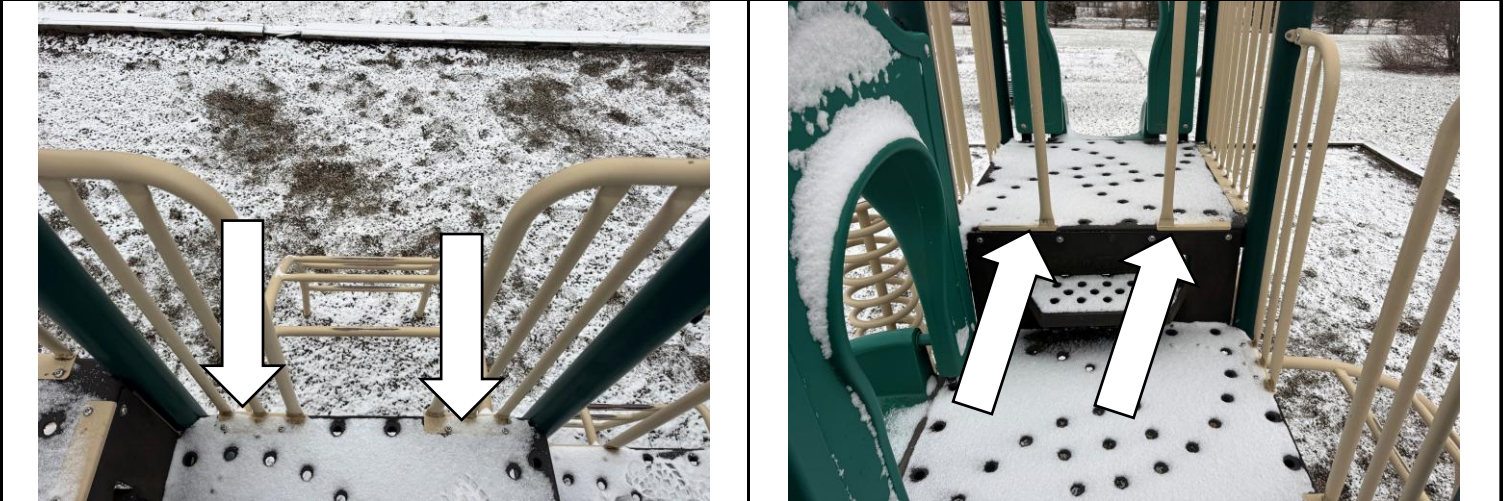
Barrier panels (loose hardware)

Several barrier panels were demonstrating minor play at their connections to the platform at the time of inspection. The components were stable, however it is recommended that all hardware be tightened as soon as possible to prevent unintentional loosening of the components.

The condition of all hardware should be monitored during daily/weekly inspections and tightened as required.
