Slope Stability Assessment

Slope Stability Assessment – 45 Springer Street
Komoka, ON

LON-00016454-GE

October 17, 2018
Updated April 9, 2019
Updated August 27, 2020

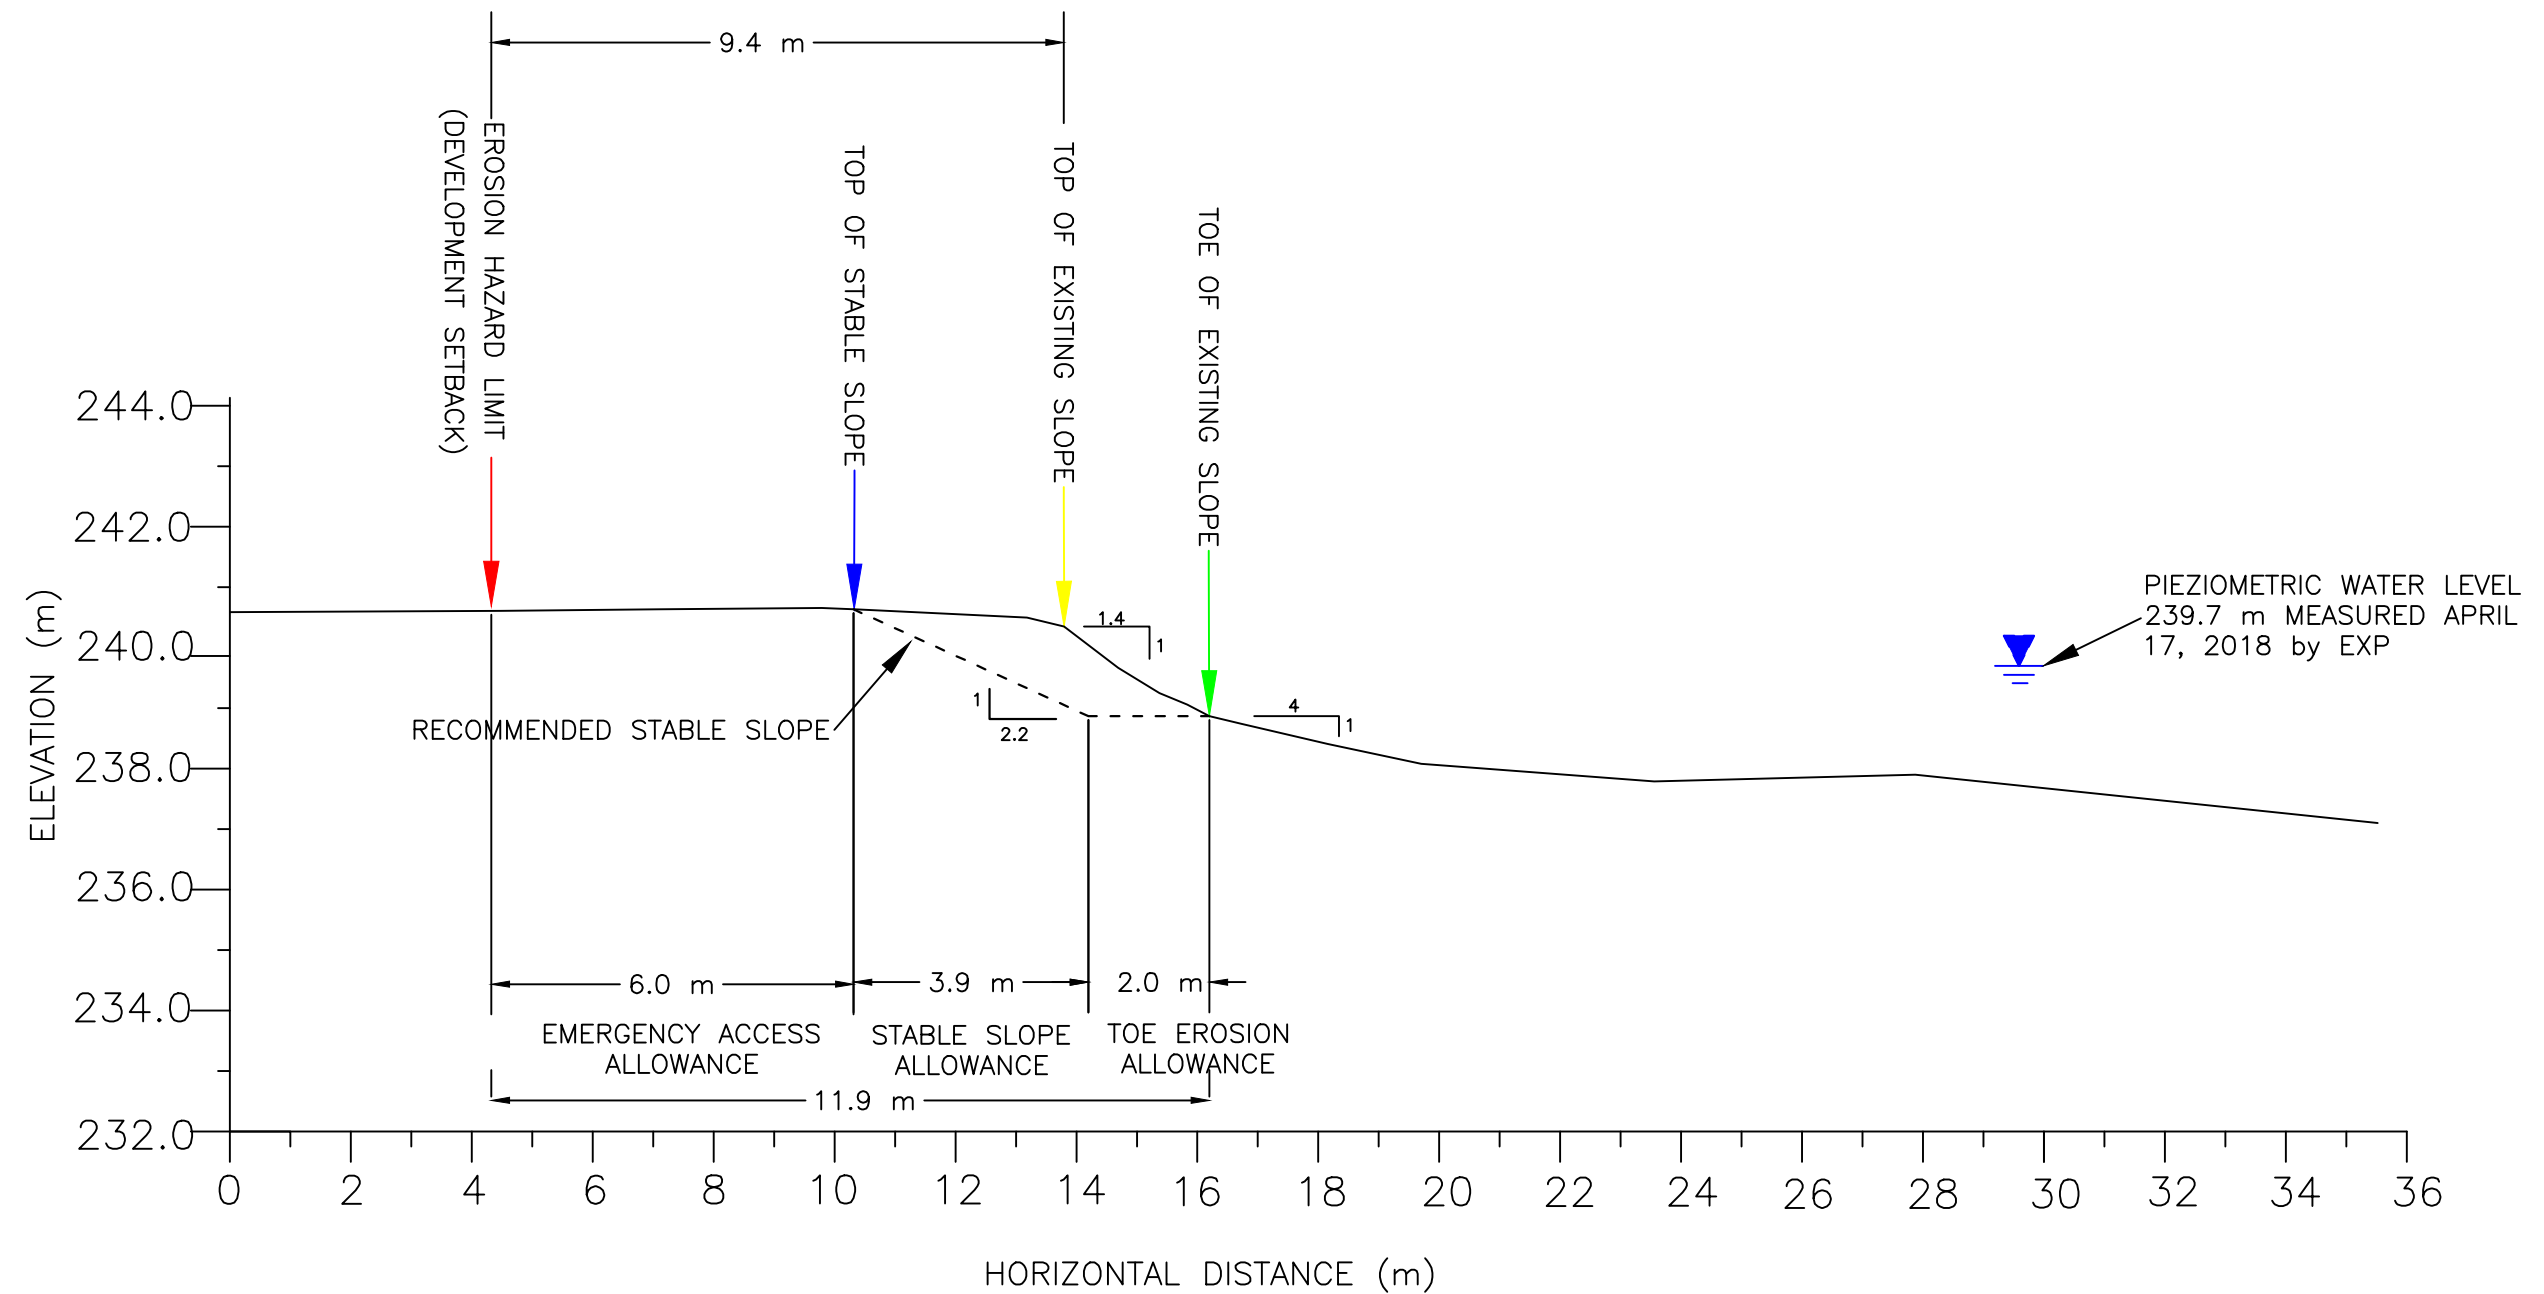
Existing Slope Cross Section A - A'

Cross-Section	Description of Failure Mode	Computed Factor of Safety
Slope Section, A-A':	Shallow Depth Failure	1.05
	Moderate Depth Failure	1.45
	Rotational Failure	1.97
Slope Section, B-B':	Shallow Depth Failure	1.09
	Moderate Depth Failure	1.51
	Rotational Failure	2.19
Slope Section, C-C':	Shallow Depth Failure	1.07
	Moderate Depth Failure	1.52
	Rotational Failure	2.01
Slope Section, D-D':	Shallow Depth Failure	1.42
	Moderate Depth Failure	1.72
	Rotational Failure	2.38

Cross Section	Toe Erosion Allowance, m	Stable Slope Allowance, m	Emergency Access Allowance, m	Erosion Hazard Allowance, m (measured from toe of slope)	Erosion Hazard Allowance, m (measured from top of slope)	Applied Erosion Hazard Allowance, m (measured from top of slope)
A-A'	2.0	3.9	6.0	11.9	9.4	9.5
B-B'	2.0	7.4	6.0	15.4	7.6	9.5
C-C'	2.0	6.4	6.0	14.4	8.6	9.5
D-D'	2.0	6.4	6.0	14.4	7.1	9.5

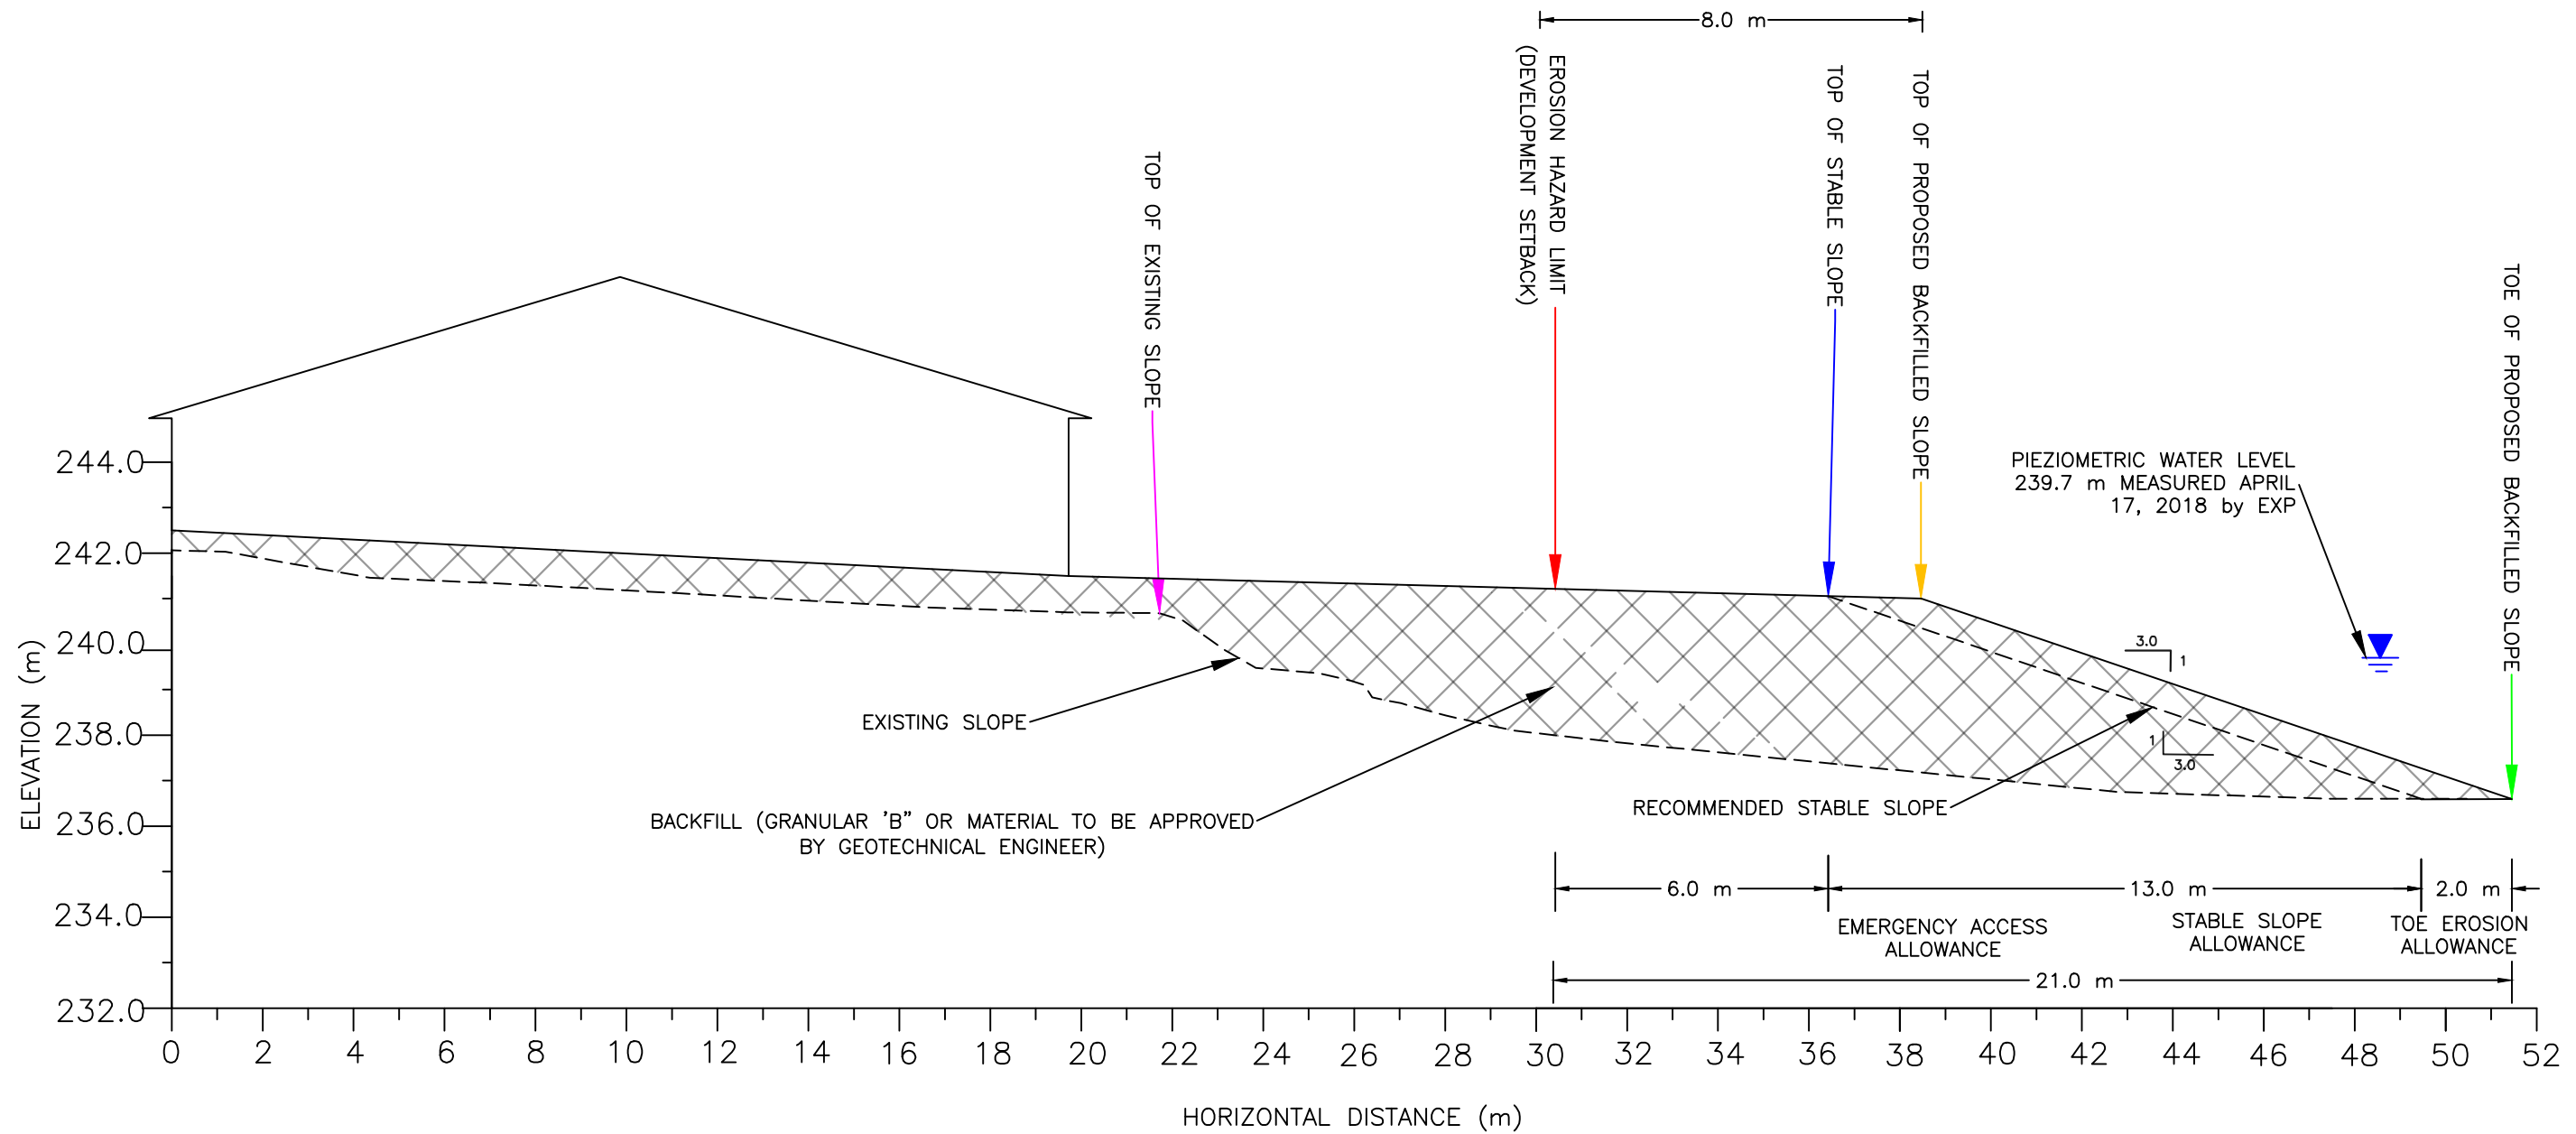
Proposed Backfilled Lot Cross Section D - D'

Backfilled Slope Section, D-D':	Shallow Depth Failure	1.65
	Moderate Depth Failure	1.69
	Rotational Failure	2.10

Cross Section	Toe Erosion Allowance, m	Stable Slope Allowance, m	Emergency Access Allowance, m	Erosion Hazard Allowance, m <i>(measured from toe of slope)</i>	Erosion Hazard Allowance, m <i>(measured from top of slope)</i>
A-A'	2.0	9.0	6.0	17.0	8.0
B-B'	2.0	12.5	6.0	20.5	8.0
C-C'	2.0	14.6	6.0	22.6	8.0
D-D'	2.0	13.0	6.0	21.0	8.0

It is recommended Granular “B” material be used to backfill the lots. The fill material should be benched into the existing slope where possible. Below the water surface of the pond, it is recommended to occasionally ‘notch’ the existing slope to interlock the new fill material with the existing soils. After backfilling the lots, the slopes should be revegetated. End dumping placement of the fill will induce uncontrolled long-term consolidation of the fill. No buildings should be founded on top of the backfilled lots unless founded on a properly design foundation.

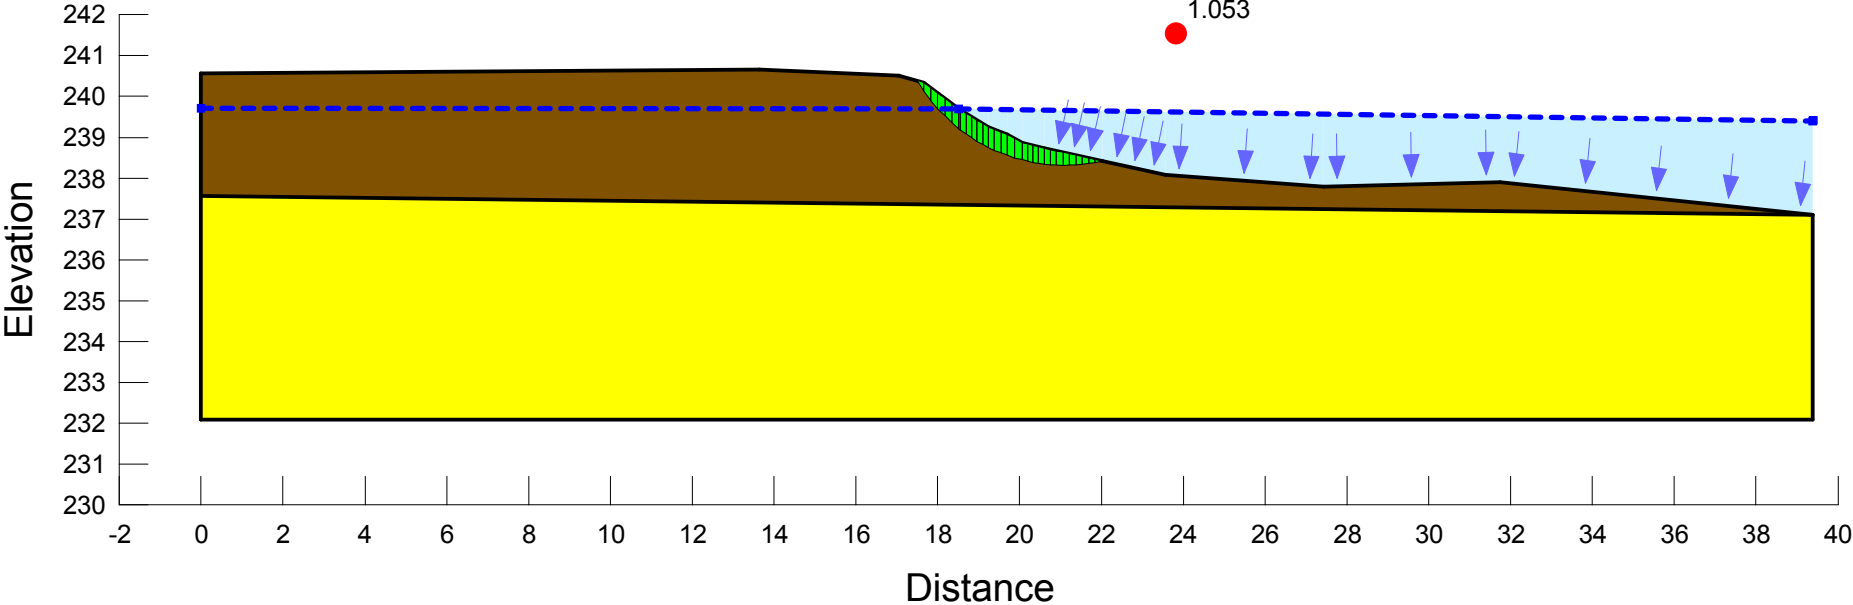
Cross Section A- A' - Shallow Failure

Due to the presence of many mature trees with deep established root systems, and an abundance of other vegetation situated on the slope, shallow failures should not be

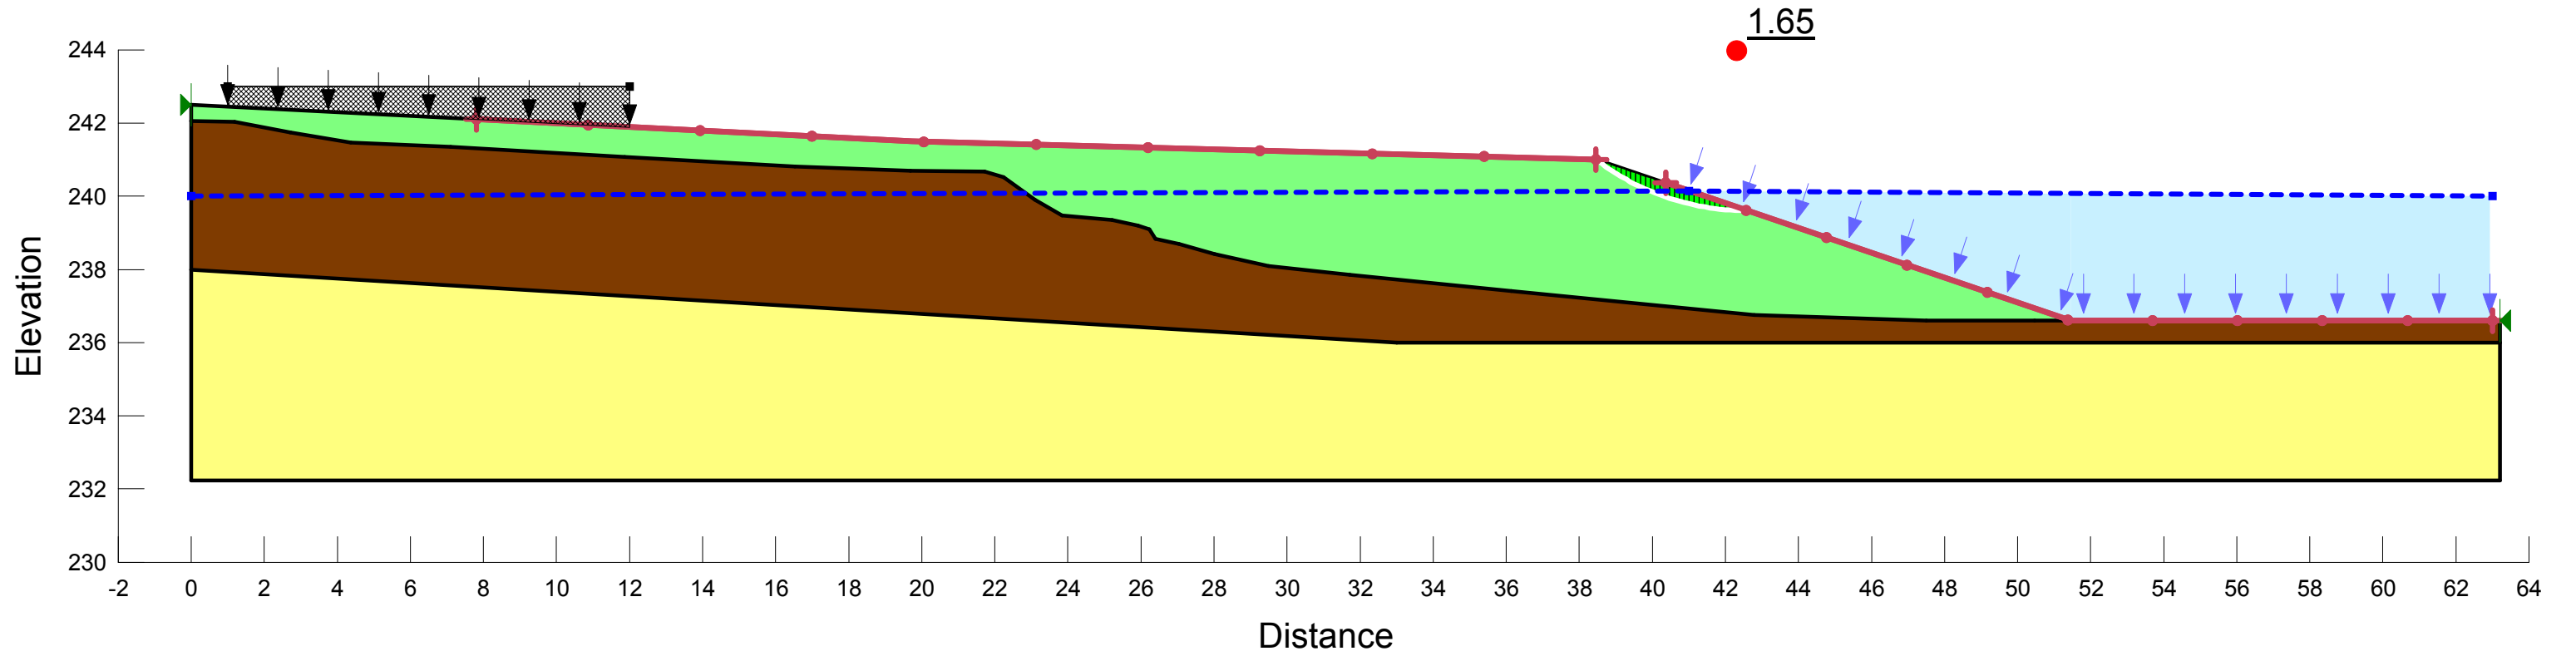
Cross Section D-D' Extended Lot - Shallow Failure

One cross section was assessed at Cross Section D-D using a computerized stable slope software (Slope/W) which is anticipated to reflect the worst case scenario. Results of the computer analysis are provided in the Table below. The minimum FOS was 1.65 for a shallow failure, which is above the recommended FOS of 1.4.
