Hydrogeological Assessment

12 Lot Subdivision Development
10379 Ilderton Road, Ilderton

LON-00010753-GB

September 5, 2018

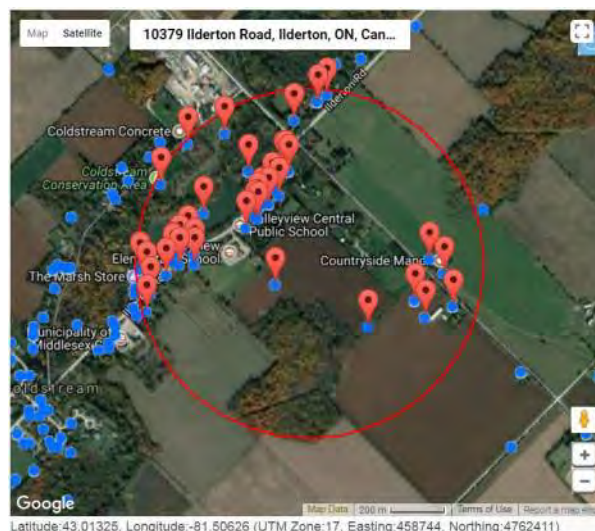
Registered MECP Wells Within a 500 m Radius

The MECP well computer data was updated as of February 2, 2018 and is summarized below.

Groundwater information provided by MECP well records indicates that there is a shallow aquifer (1.5 to 3.0 m deep or 5 to 10 ft) and an intermediate depth aquifer (3.0 to 18.3 m or 10 to 60 ft deep). The subsurface strata indicated in the MECP Well Records are generally clay over sand and gravel zones.

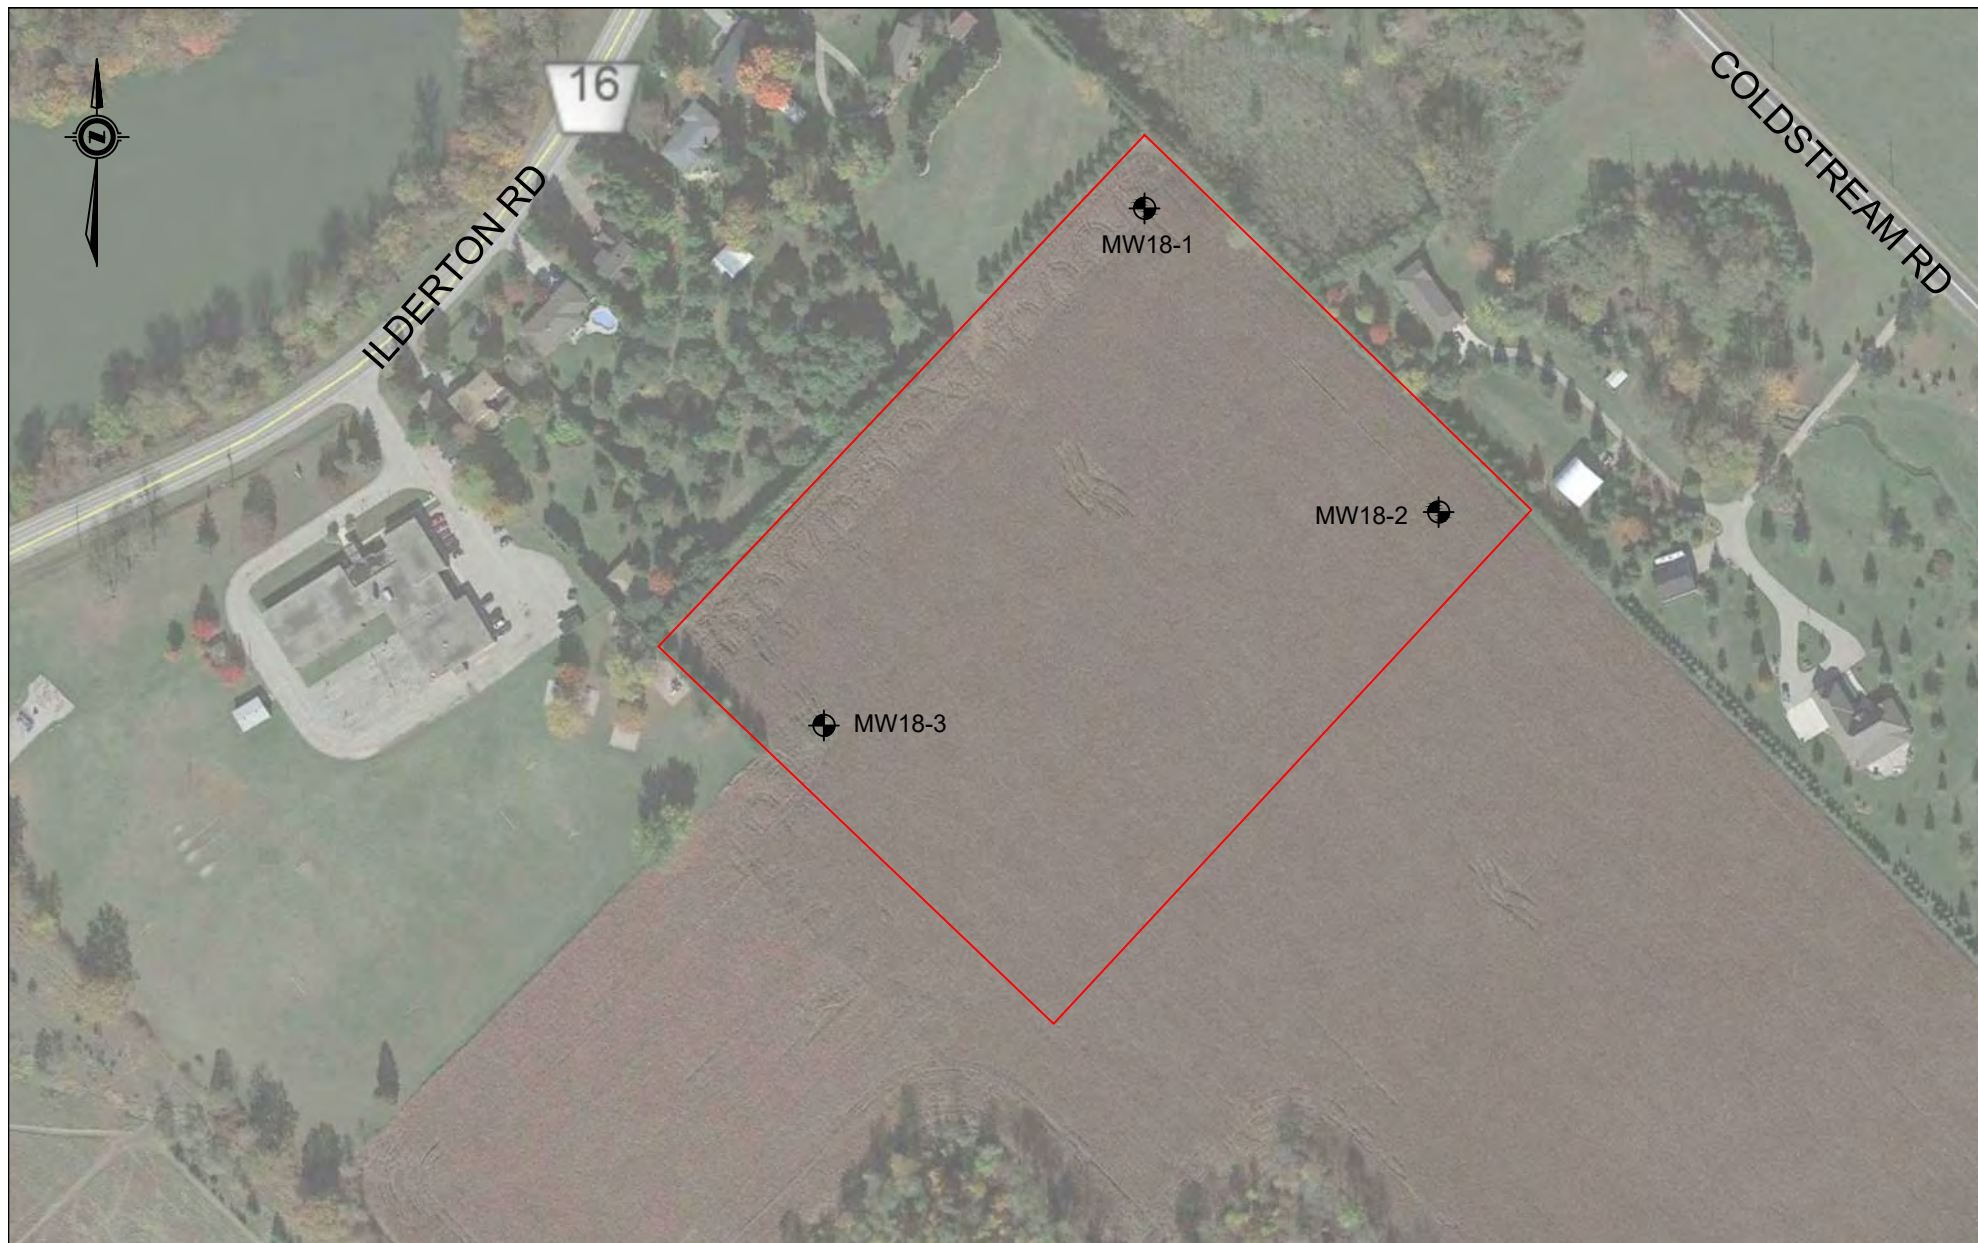
EXP Services Inc. 15701 Robin's Hill Road, London, ON, N5V 0A5	
DATE SEPTEMBER 2018	SCALE NTS
PROJECT NO. LON-00010753-GB	DWG. 1

The fieldwork for the current investigation was carried out on April 4th and 6th, 2018. In general, the site investigation consisted of drilling three (3) boreholes at the locations denoted on **Drawing 1** as MW18-1 to MW18-3, inclusive.

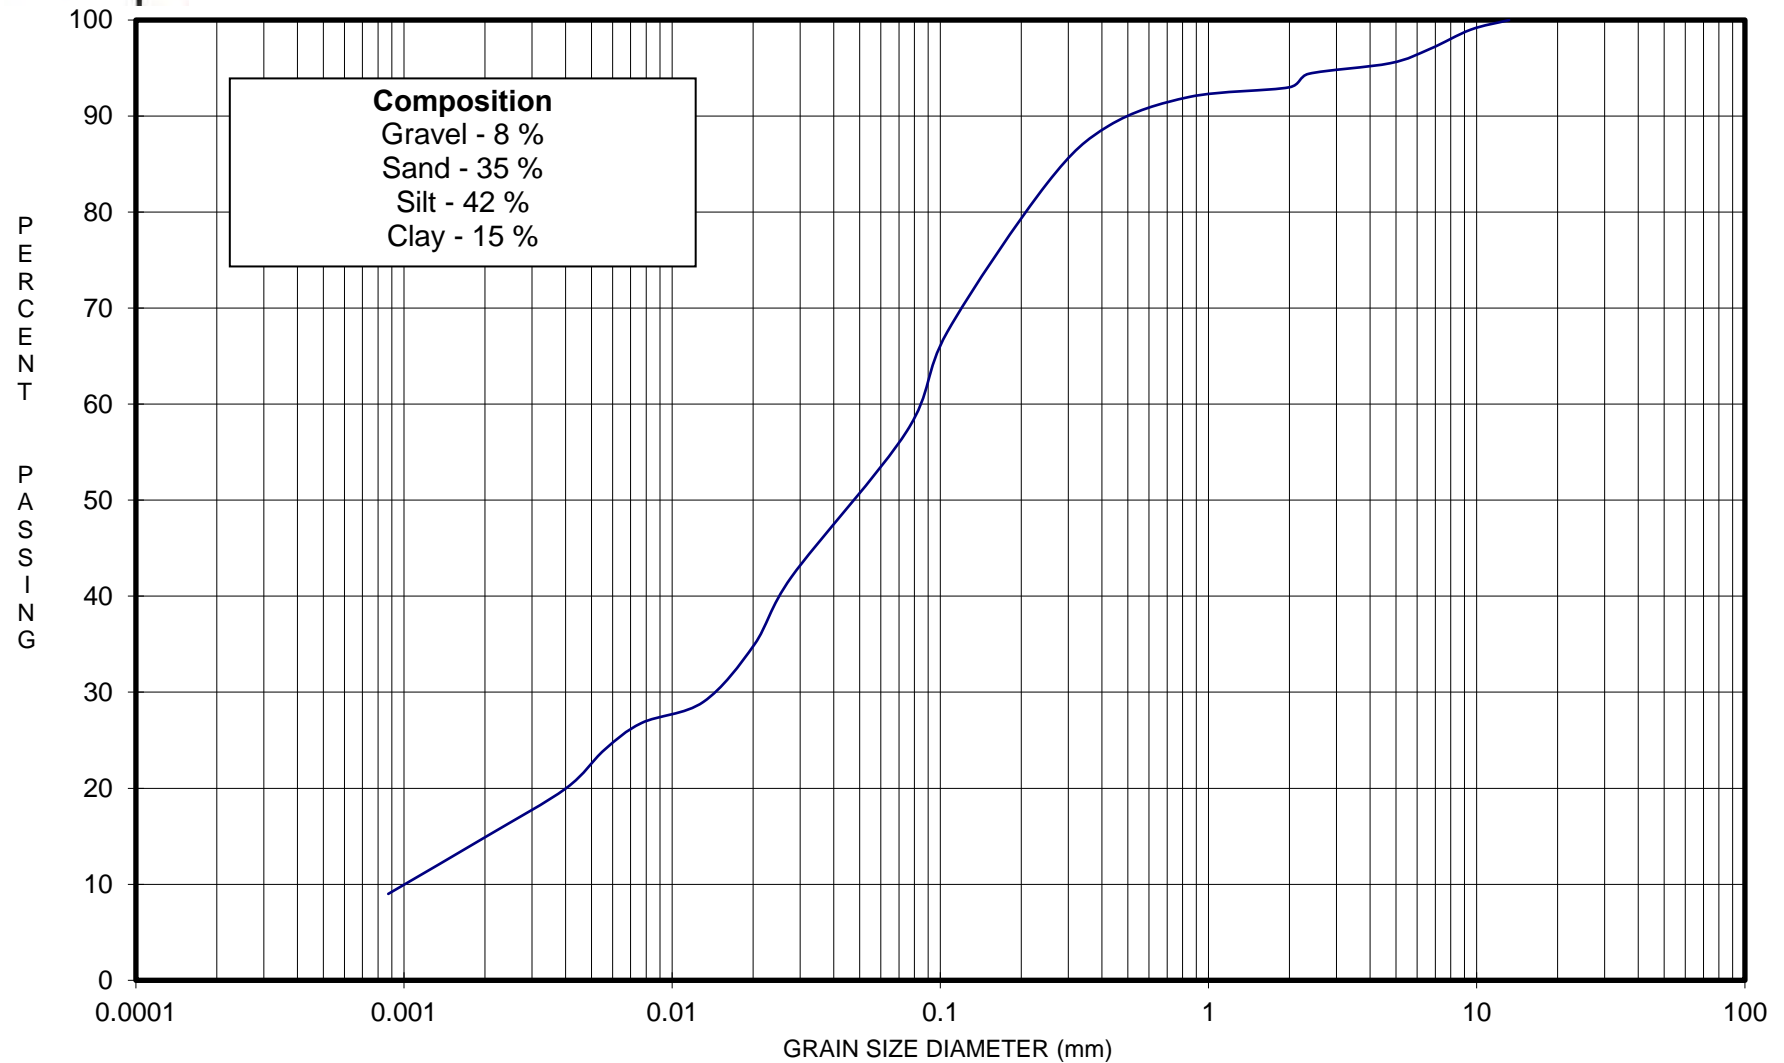
CLAY	FINE	MEDIUM	COARSE	FINE	MEDIUM	COARSE	FINE	MEDIUM	COARSE	
	SILT			SAND			GRAVEL			
MODIFIED M.I.T. CLASSIFICATION		Sample Description: MW18-2 Depth 1 m bgs ML Soil Type					Project: LON00010753GB			Figure 1

Silt was encountered beneath the topsoil in all boreholes. The silt was brown in colour with trace to some sand or sand partings, some clay and trace gravel and cobbles. It was in a stiff to very stiff consistency and compact relative density and moist to very moist. A grain size analysis was conducted on a sample obtained from MW18-2 near 1.0 m bgs. The composition is summarized below and found in **Appendix B** as Figure 1.

Sample	Composition, %			
	Gravel	Sand	Silt	Clay
MW18-2, 1.0 m bgs	8	35	42	15

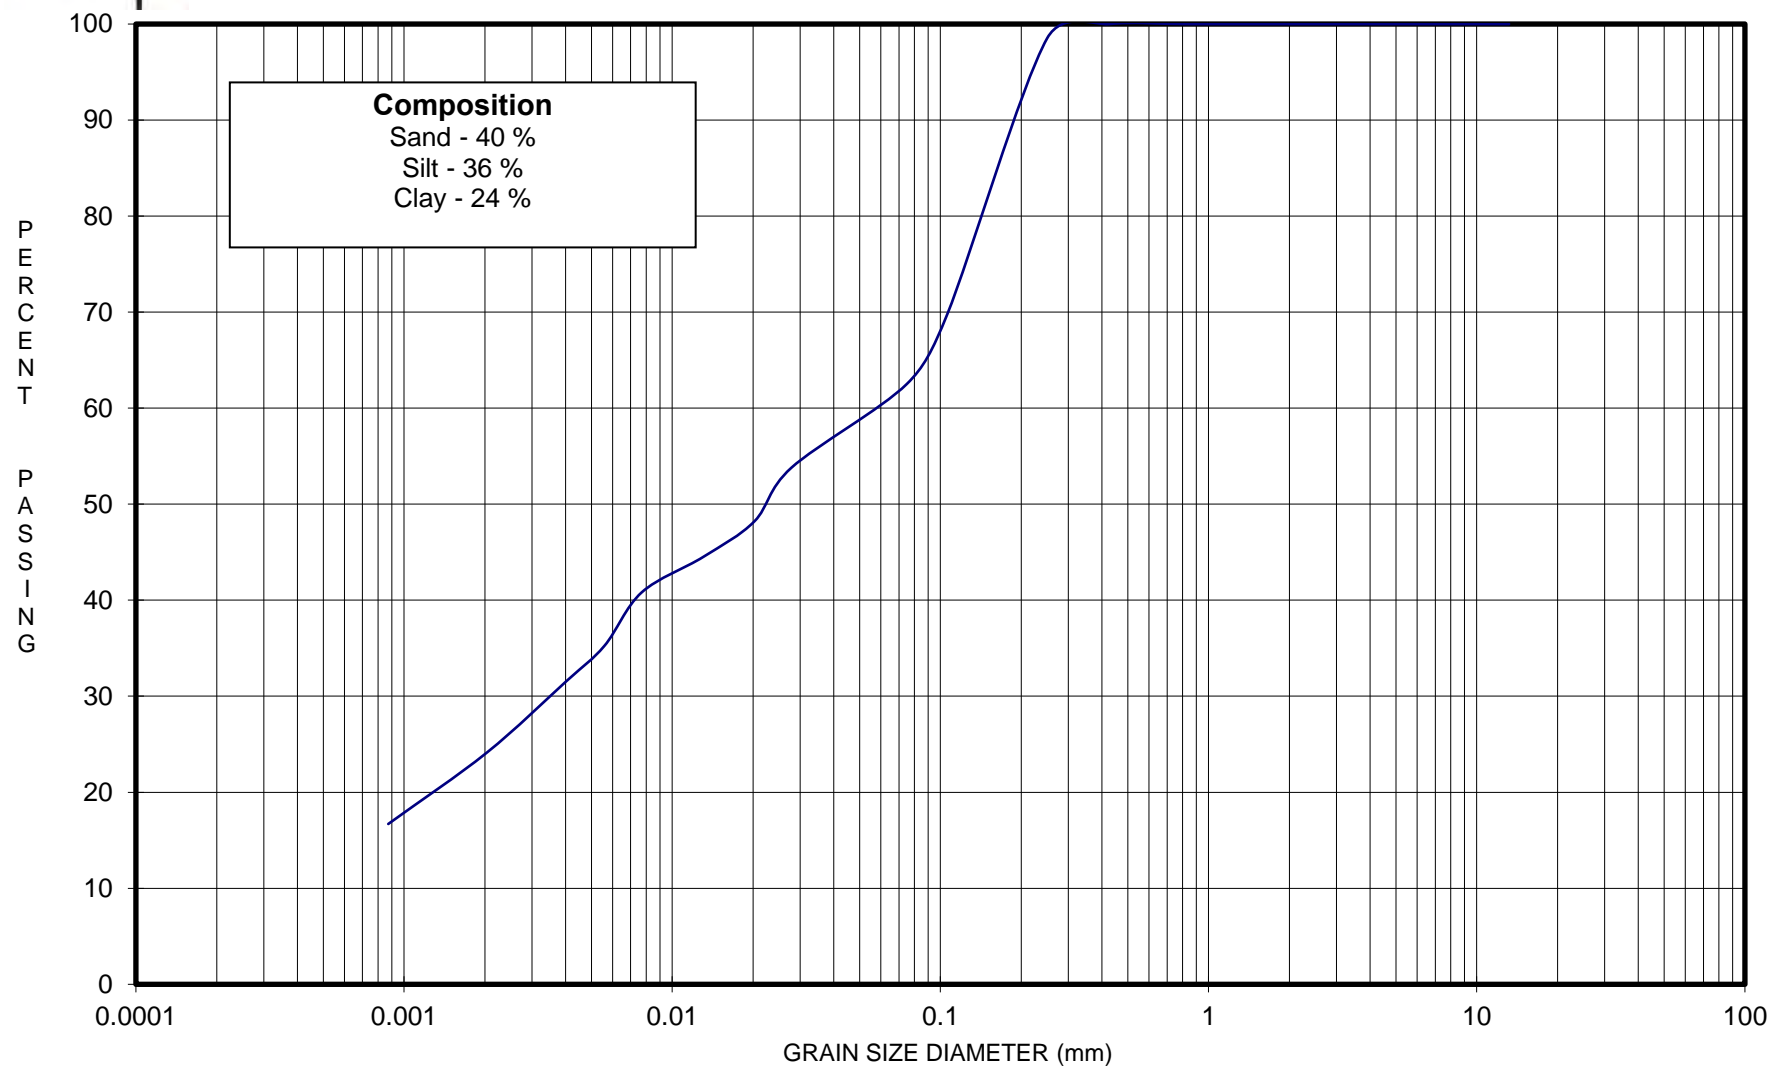
CLAY	FINE	MEDIUM	COARSE	FINE	MEDIUM	COARSE	FINE	MEDIUM	COARSE	
	SILT			SAND			GRAVEL			
MODIFIED M.I.T. CLASSIFICATION		Sample Description: MW18-1 Sa1 Depth 9.1-9.8 m bgs					Project: LON00010753GB			Figure 2

All three boreholes were terminated in a silty sand. The silty sand layer occurred 9.6 m bgs, at MW18-1 and MW18-3 and 6.7 m bgs at MW18-2. It was described as grey in colour, compact and wet. Two grain size analyses were performed on samples from MW18-1 near depths of 9.1 to 9.8 m bgs and 10.7 to 11.3 m bgs. The compositions are summarized below and found in **Appendix B** as Figures 2 and 3.

Sample	Composition, %			
	Gravel	Sand	Silt	Clay
MW18-1, 9.1 to 9.8 m bgs	0	40	36	24
MW18-1, 10.7 to 11.3 m bgs	2	61	24	13
