HYDROGEOLOGICAL LEVEL 1 AND LEVEL 2 ASSESSMENTS

PROPOSED MAES PIT

Part Lots 1 and 2, Concession 2, Township of Middlesex Centre
(Formerly Lobo Township), County of Middlesex, Ontario

JOHNSTON BROS. (BOTHWELL) LIMITED

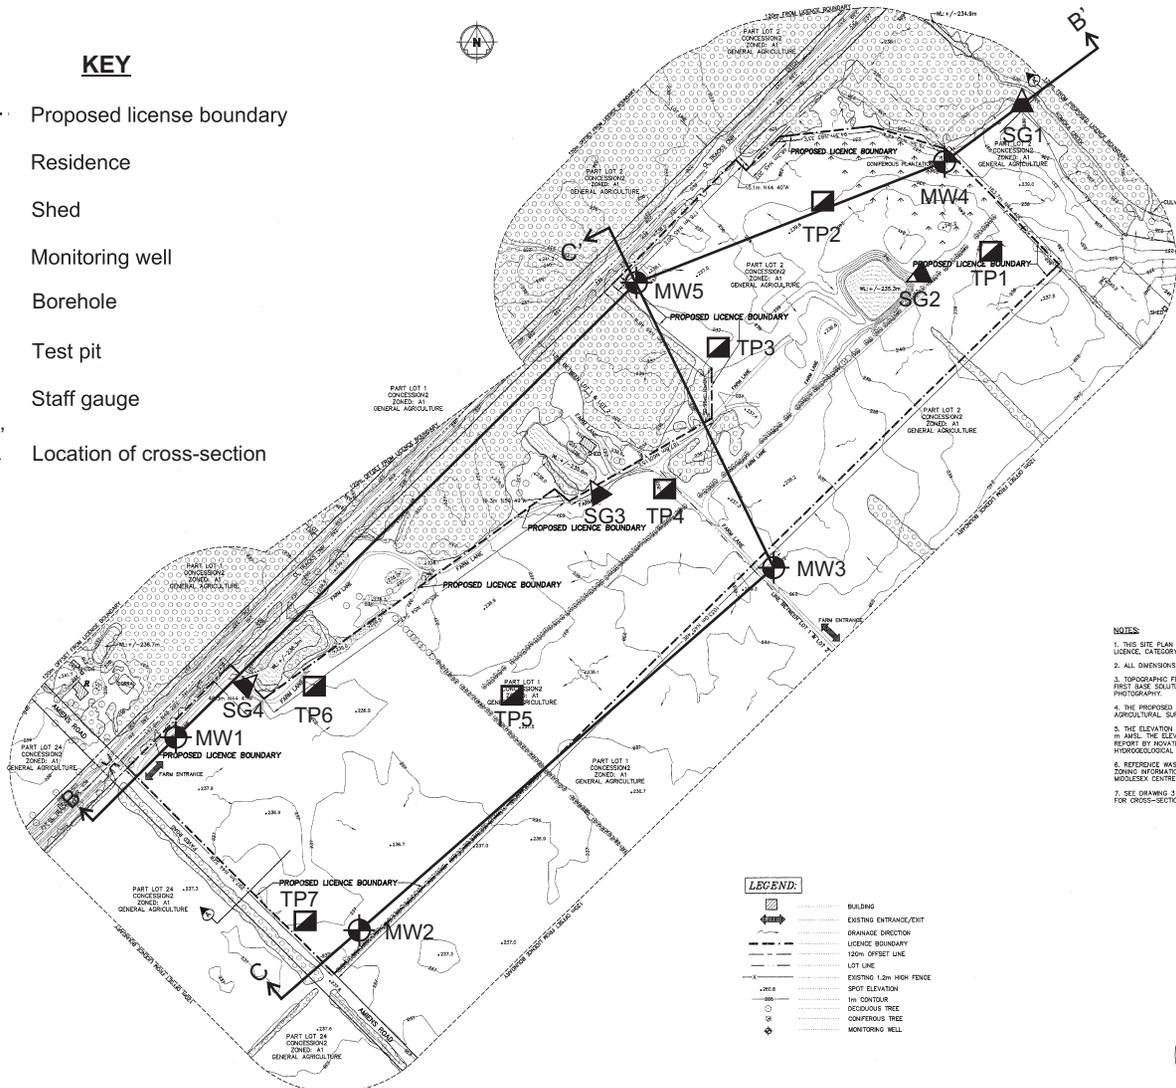
Figure 2
 Maes Pit
 Johnston Bros. (Bothwell) Ltd.
 March 20, 2017

Detailed site topography is shown in Figure 2, which is Drawing 1 of 3 (Bradshaw, 2016) with 1 m contour intervals. According to this drawing, the highest elevation is found at the eastern part of the Site which has elevation of 241 m a.s.l.

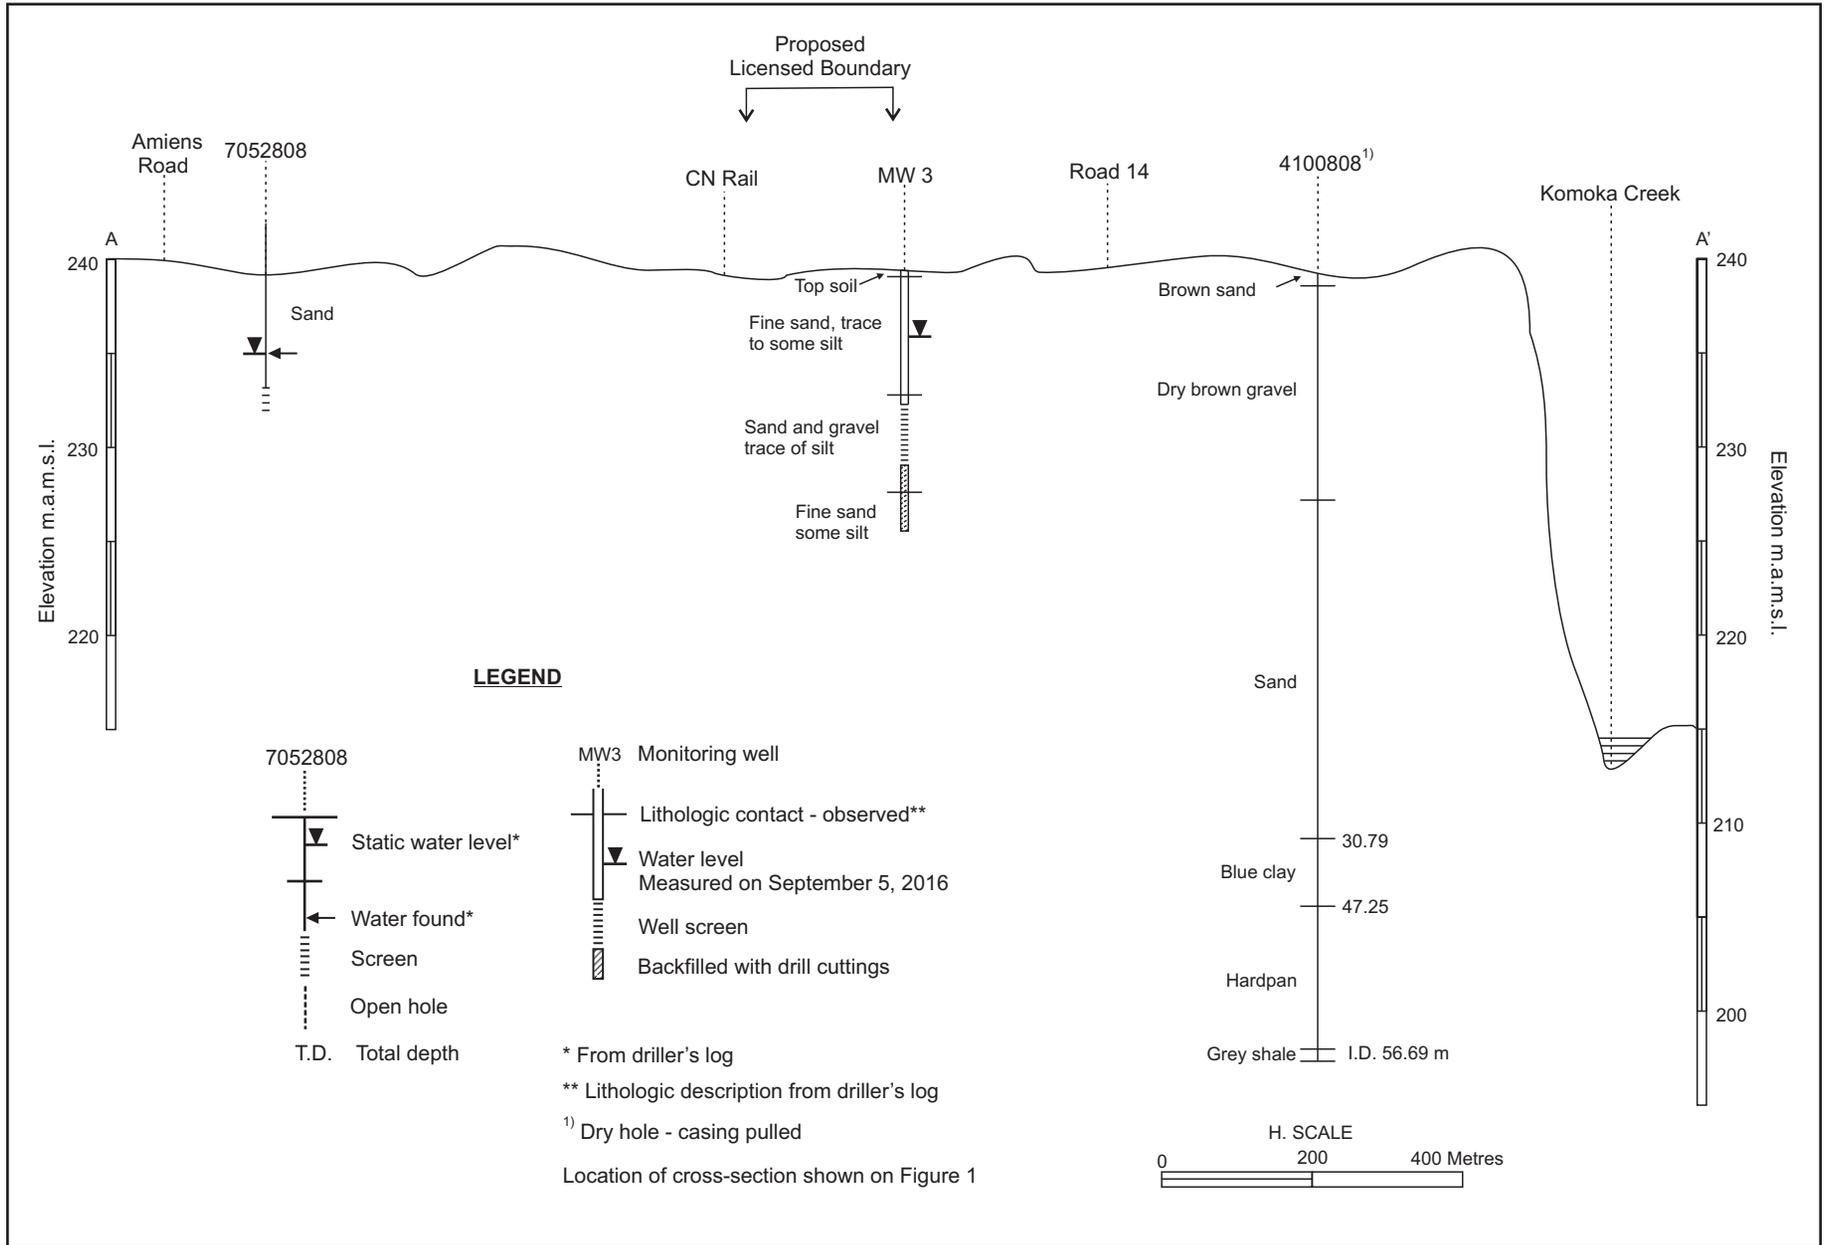
REGIONAL CROSS-SECTION A-A'

Vertical cross-section A-A' illustrates regional hydrogeological conditions in the study area (Figure 4). This cross-section, together with information shown on Figure 1, indicate that the majority of the domestic wells for which water well records are available obtain water from wells completed in shallow overburden. But there are other domestic wells which were constructed into shallow water table aquifer. These domestic wells are actually sand points for which there are no water well records on MOECC files.

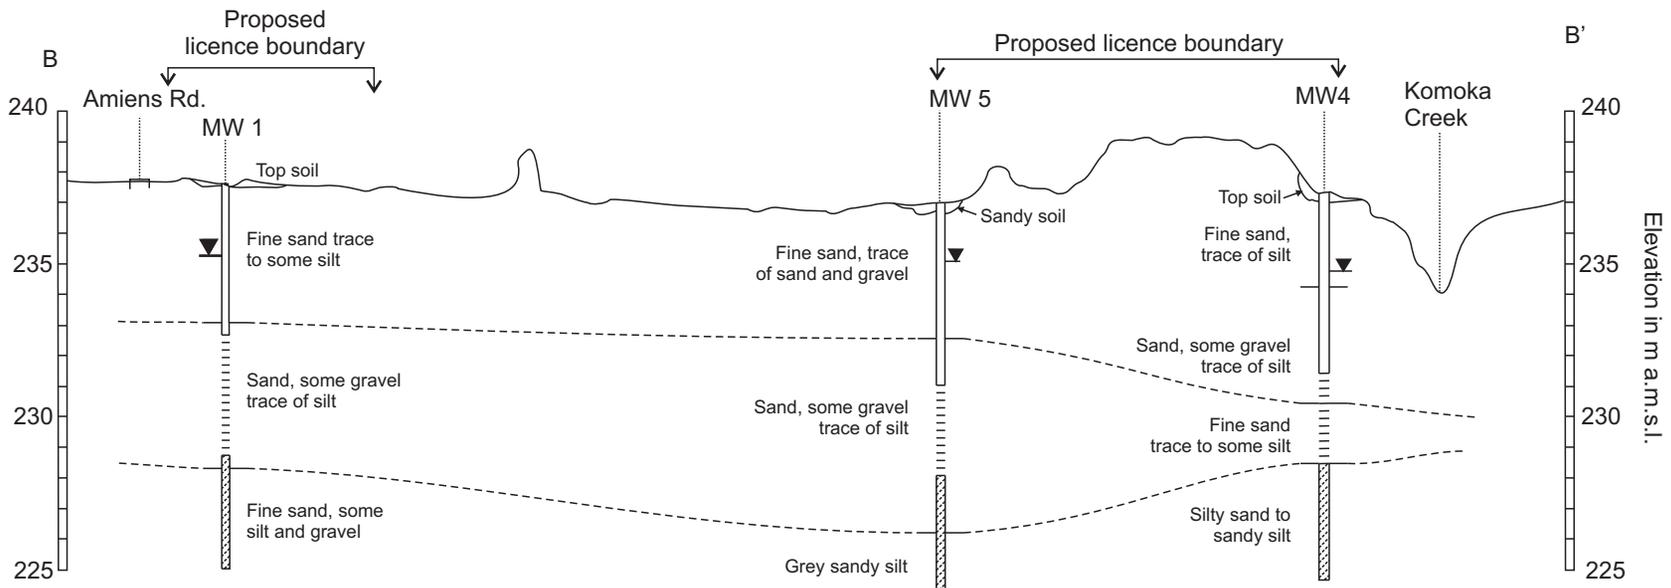
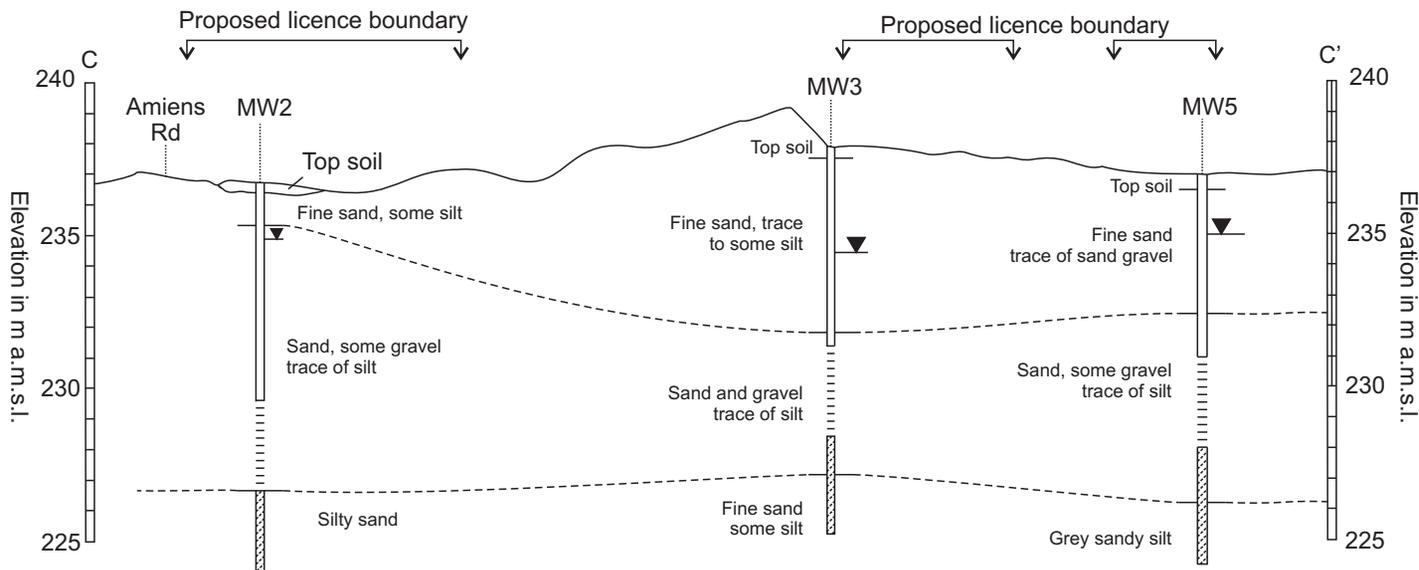
Vertical cross-sections B-B' and C-C' illustrate hydrogeological conditions in the shallow subsurface at the Site (Figure 5). They show that the deeper portions of the sand and gravel deposits are saturated, thus constituting a water table aquifer. The depth to water table from

Based on the above information, the approximate depth of sand and gravel extraction is shown on Drawing 2 of 3, and Drawing 3 of 3 (Bradshaw, 2016). This can be observed on cross-sections B-B' and C-C', as shown on Figure 5 in this report, where the aggregate extraction would take place relative to the underlying sandy silt, silty sand, and fine sand and silt.

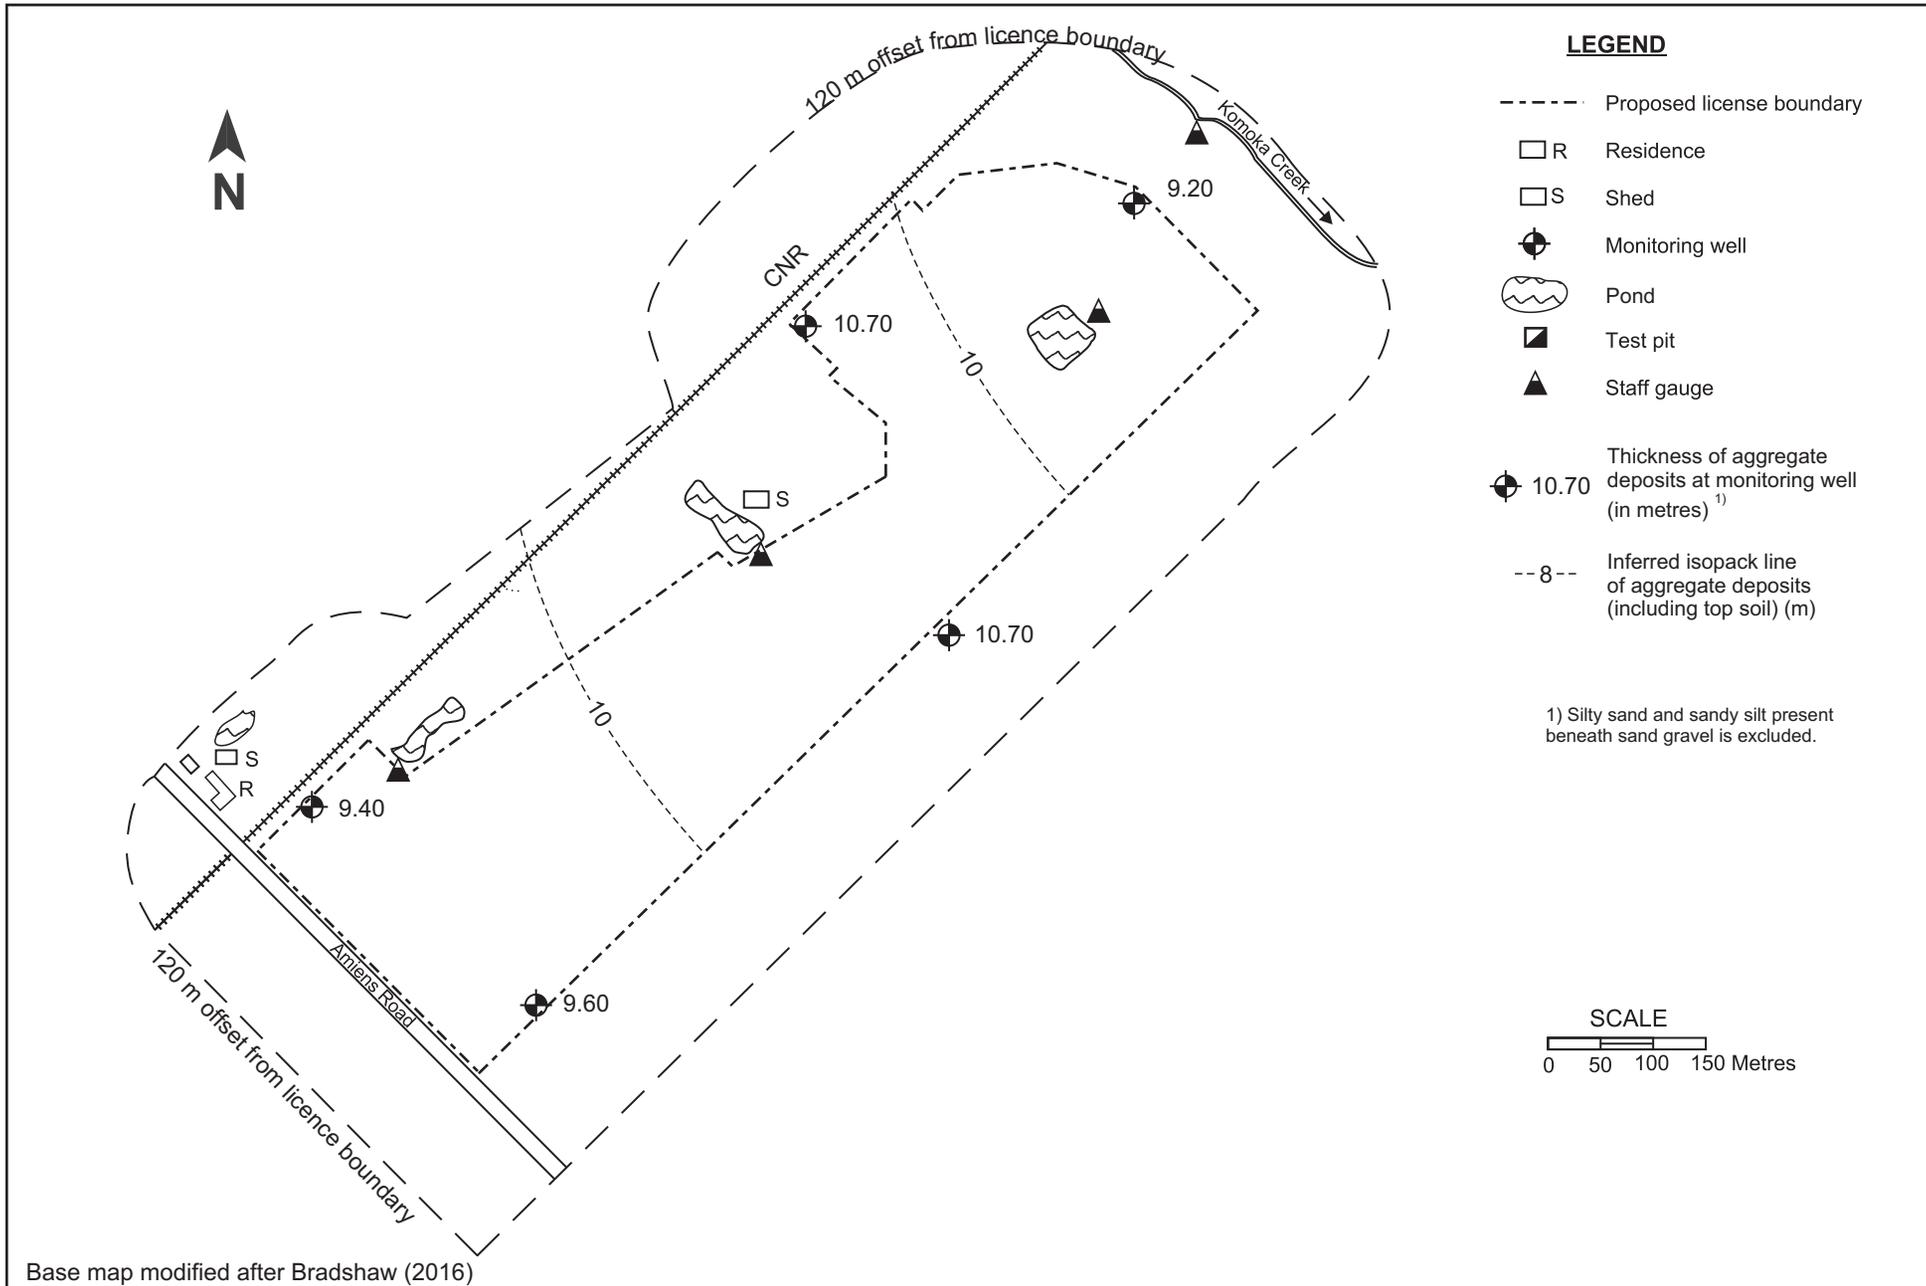
THICKNESS OF SAND AND GRAVEL	Figure 6
	Part Lots 1 and 2, Concession 2, Township of Middlesex Centre (formerly Township of Lobo), Middlesex County	Maes Pit Johnston Bros. (Bothwell) Ltd.
		November 1, 2016

The thickness of the potential aggregate deposits, including topsoil, can be observed on Figure 6. A portion of these deposits are saturated, as shown by the inferred depth to water table on Figure 8, and the thickness of saturated sand and gravel on Figure 9. Extraction of saturated sand and gravel material requires mining below the water table. Therefore, the approximate areal distribution and thickness of aggregate deposits that would be mined from below water table is shown on Figure 9.

Subsurface conditions at the Site are also illustrated on Figures 6, 7, 8, 9, 10 and 11. Information used to construct these figures was derived from borehole logs and water level monitoring results. This information is summarized in Table 4. It should be noted that the depths of the eight test pits excavated at the Site were not deep enough to provide information to be used in the construction of these figures.

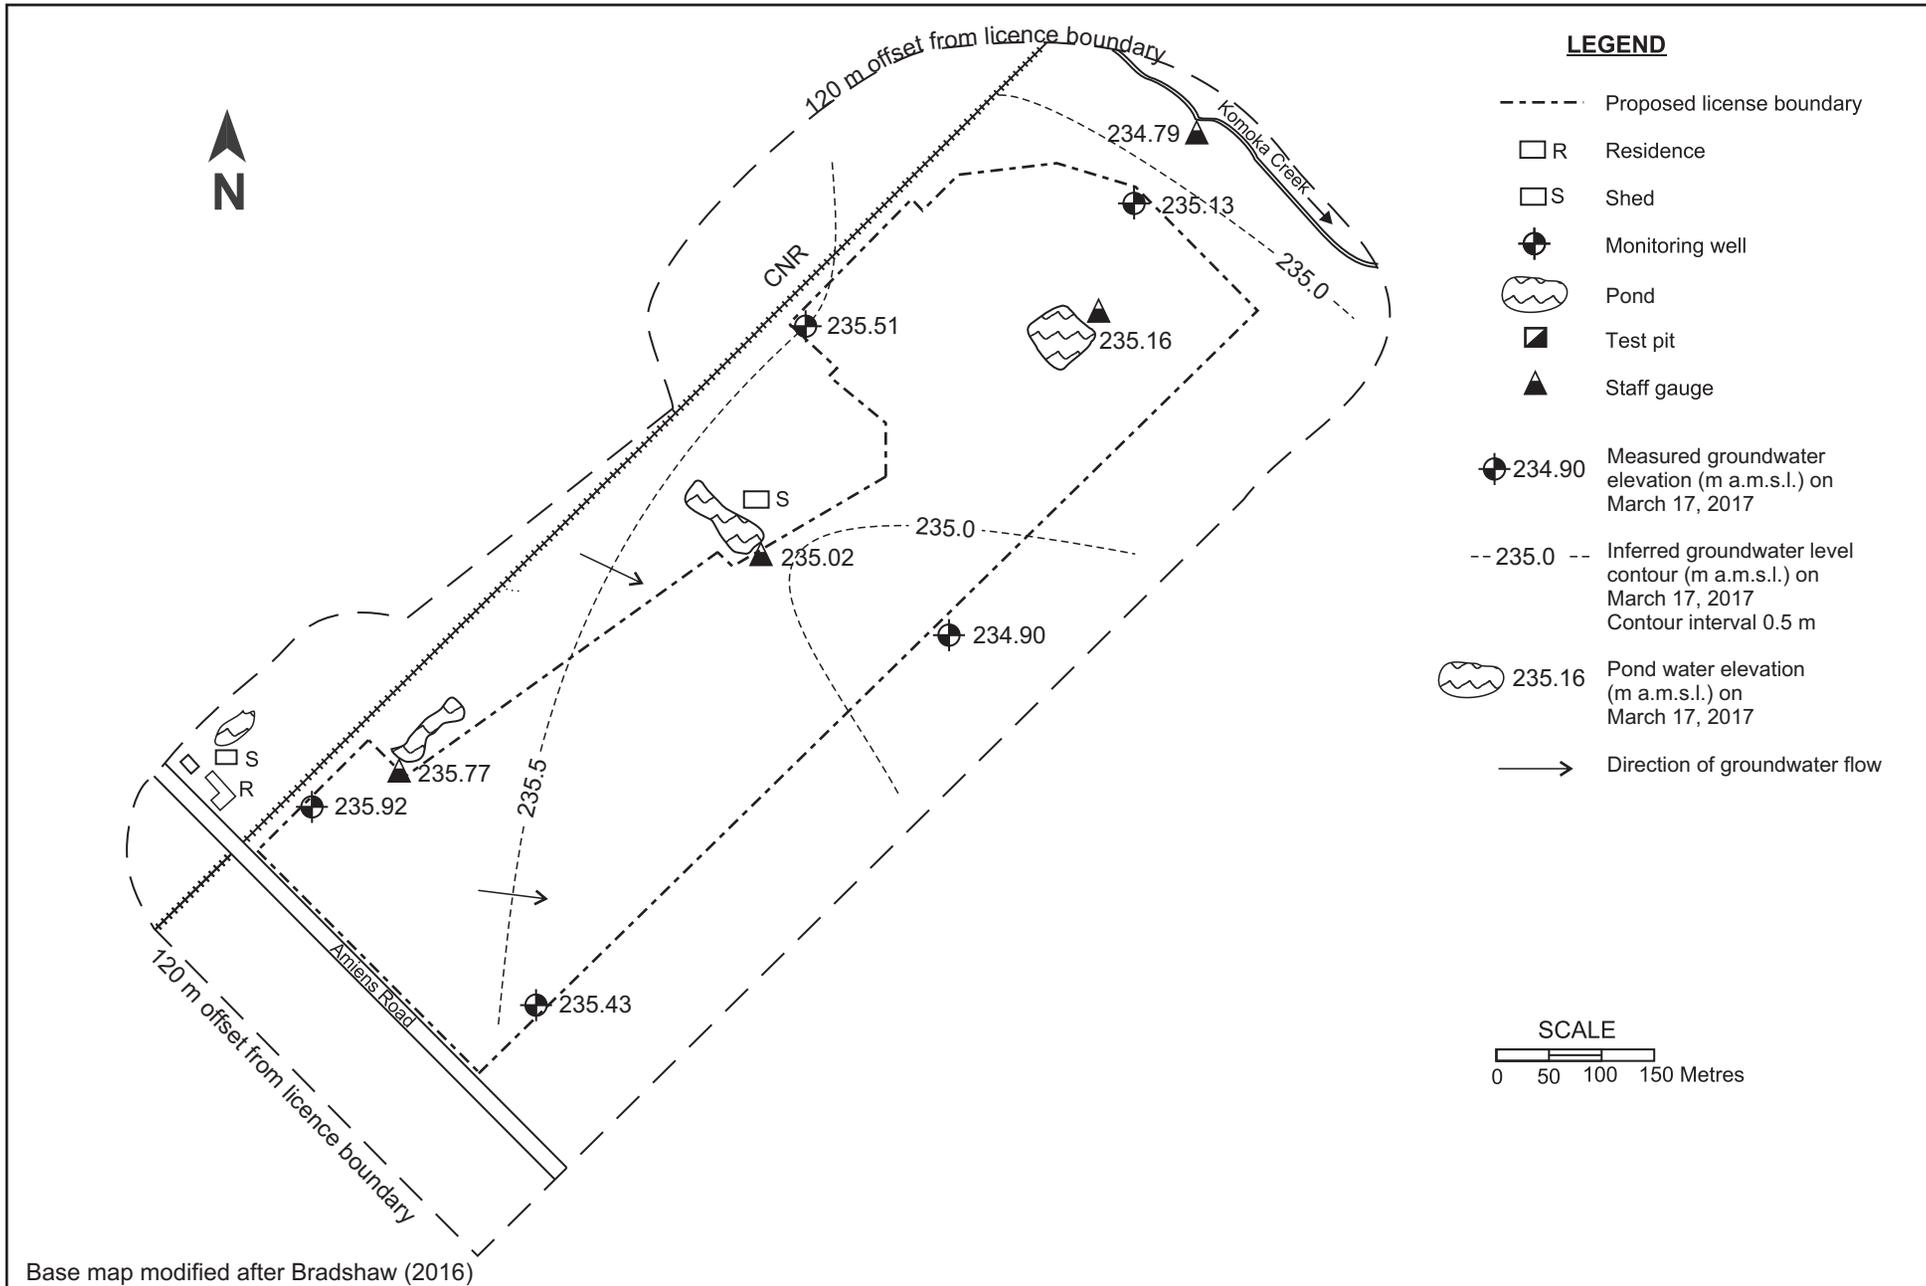
INFERRED HIGH GROUNDWATER TABLE CONFIGURATION (MARCH, 2017)

Water level elevations were used to construct water table configuration for two different conditions in the field. The water table configuration during hydraulic high (March 2017) is depicted by Figure 10, while the water table contours during hydraulic low (October 2016) are depicted by Figure 11.

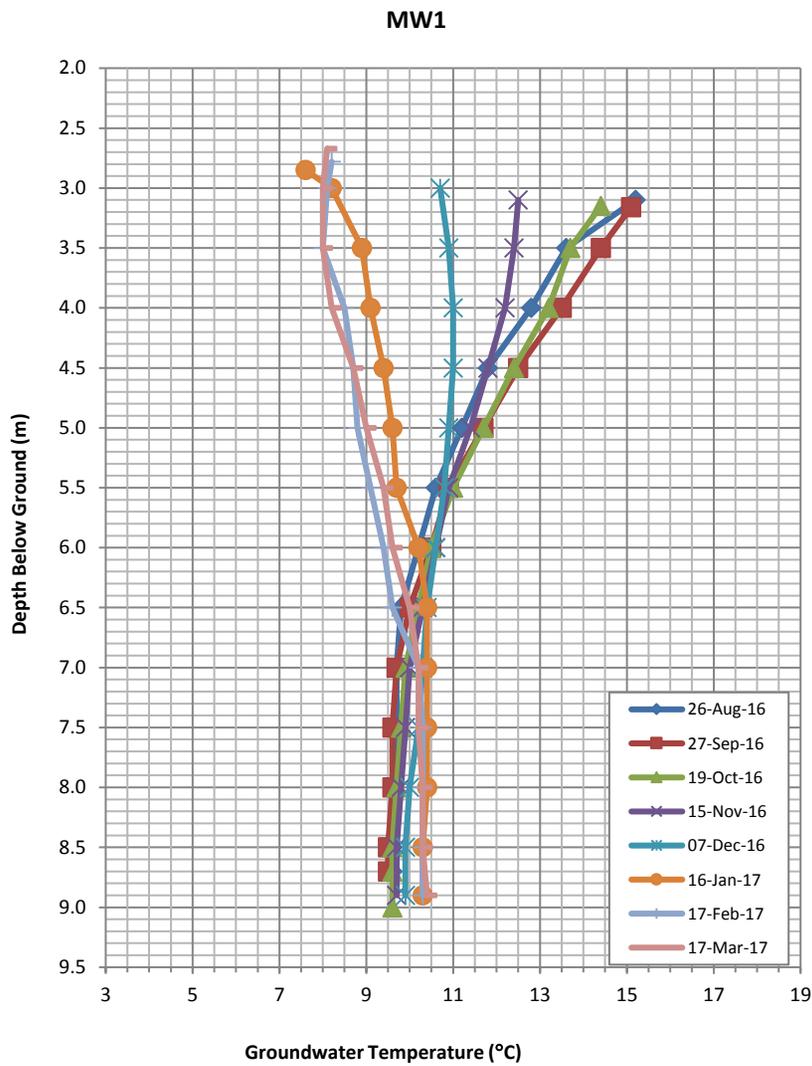
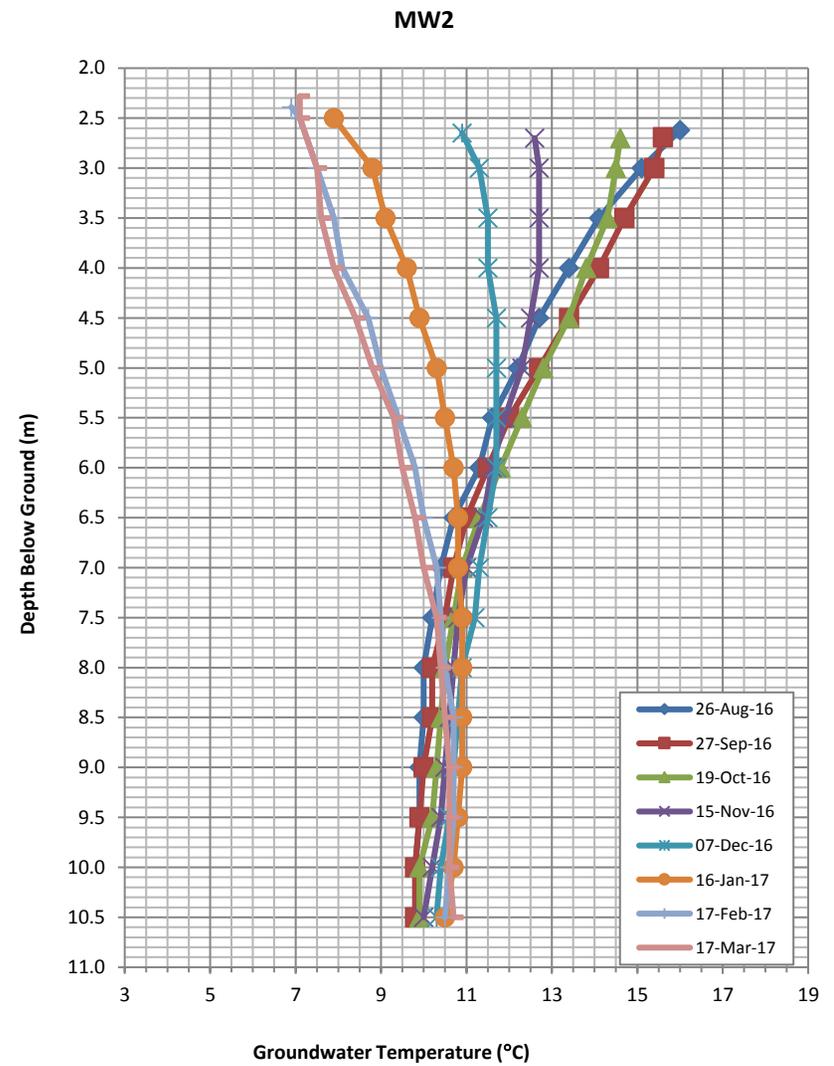
GROUNDWATER TEMPERATURE PROFILES FOR MW1 AND MW2

Typical examples to be observed and compared for shallow groundwater are in MW1 and MW2 where the temperature spread is between 7°C and 16°C and the depth to water levels are between 2.5 and 3.5 m below ground surface. At monitoring well MW3 the water levels are slightly deeper at 4.0 to 4.5 m below ground, and the temperature spread is slightly narrower between 9°C and 15°C (Figure 15).

It is worth noting that coldest temperature at the bottom of the monitoring wells is reported to be in the August to September time period and the warmest is during the January to February time period. In the shallower groundwater zones, the conditions are reversed.

As the air and ground surface cools off in the fall, the colder air temperatures progressively move into the subsurface. Consequently, temperature profiles start shifting to the left, beginning in November. We could think of it as a transient cool wave, slowly moving into the subsurface. This continues until the spring snowmelt in late February, March, and early April, when large quantities of cold water infiltrate into the ground, reaching the saturated zone of the water table and then mixing with groundwater. This is applicable for the shallow saturated zone when the depth to water table is less than 1.5 m. But as we move deeper into the aquifer the temperature spread becomes narrower.

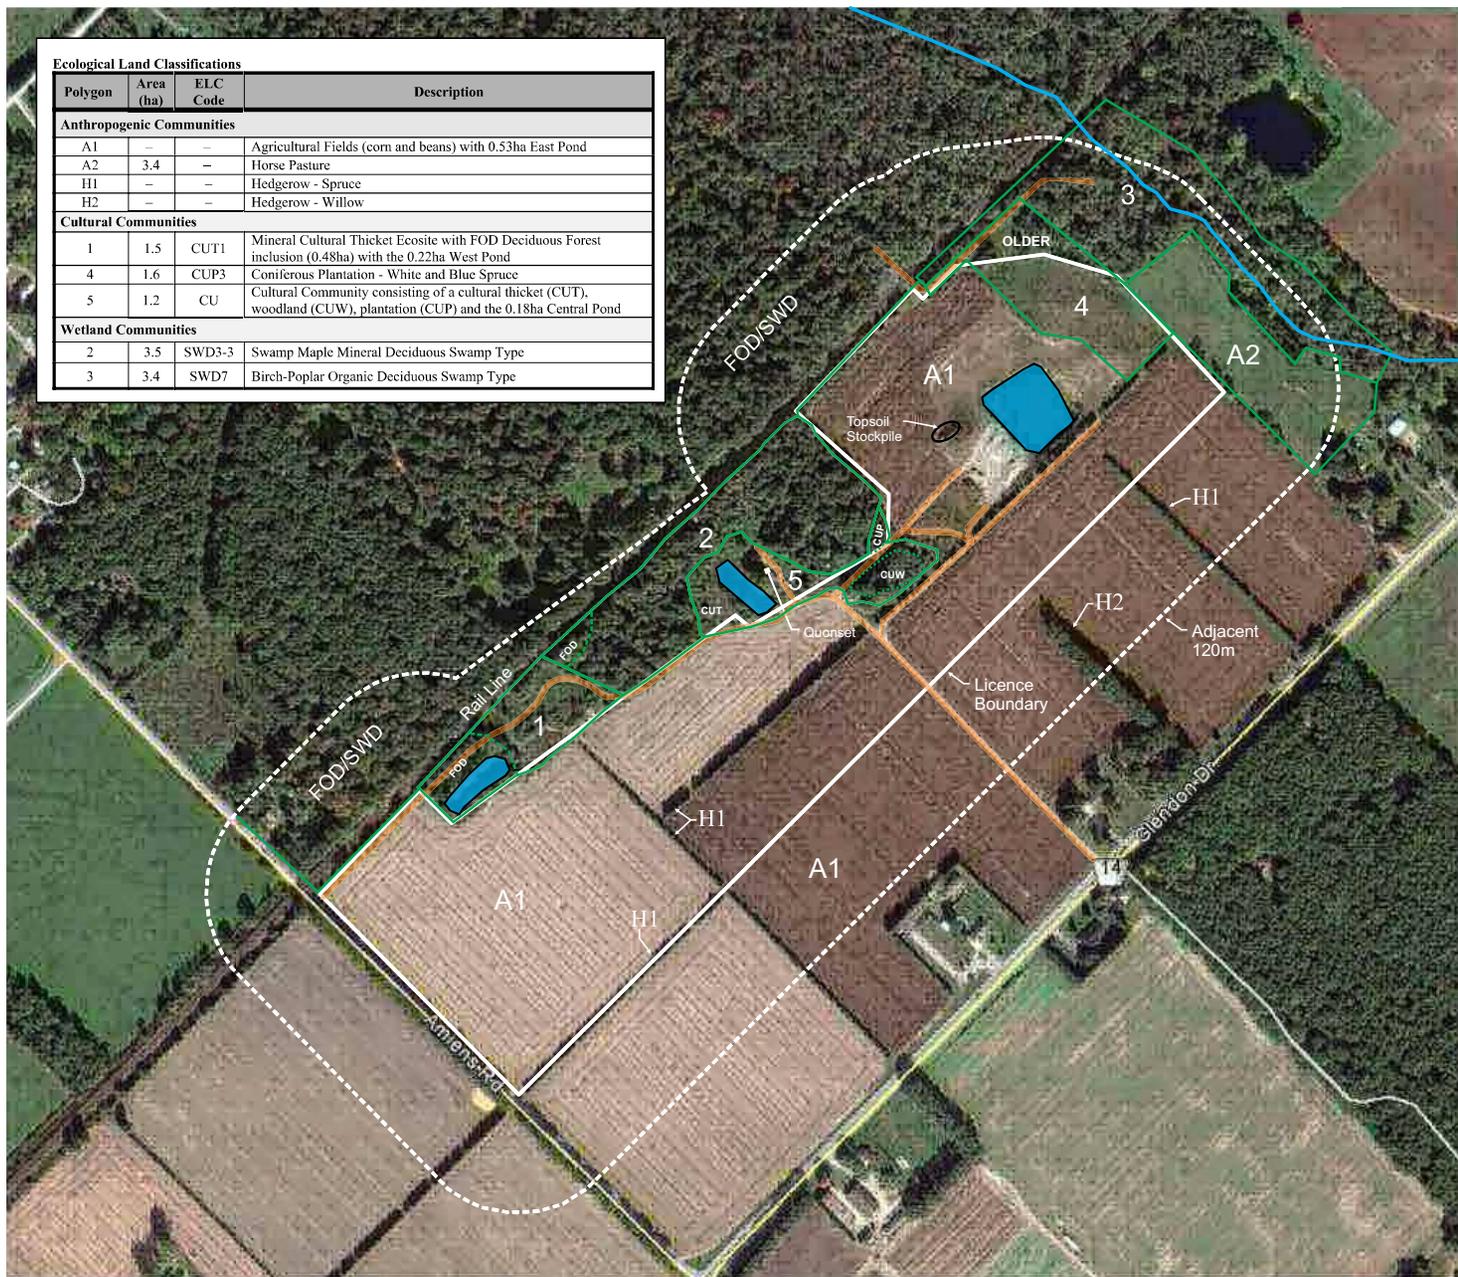
Figure 6 – Vegetation Communities from Natural Environment Report
(Biologic, 2017)

Natural environment including vegetation communities on the Site and in the adjacent area were assessed by Biologic Incorporated in their report (Biologic, 2017). Vegetation communities on the Site and adjacent area are depicted by Figure 6 given in Appendix A. The adjacent area to the north and northeast is designated as a Provincially Significant Wetland (PSW) and is identified as Komoka Creek Wetland (www.utrca.ca). The latest Upper Thames River Watershed Report Card for Komoka Creek is available for 2012, and is provided in Appendix G of this report.

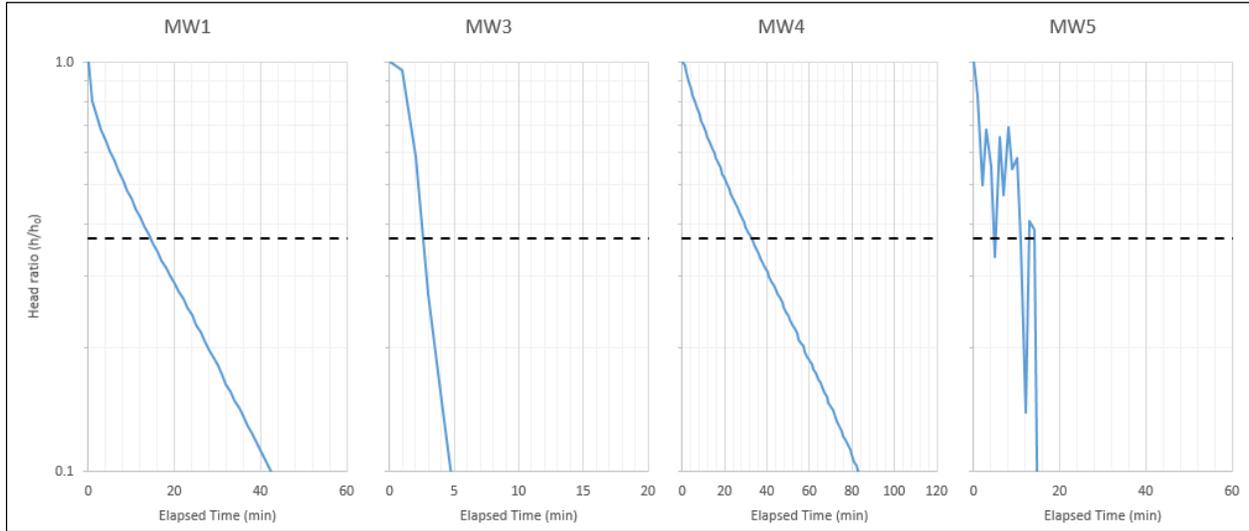
Figure D1. Results of falling head test, with 37% line identified.

t₃₇ = time it takes for water level to fall 37% of initial change (s)

The parameter t_{37} was obtained from the graphs shown on Figure D1. For monitoring wells MW1, MW3, and MW4 it was clearly visible from the field data, but for MW5 it was not. The reason for the sporadic response of the water levels is unclear, and the test was repeated with similar results. Nevertheless, t_{37} was approximated for MW5, and the hydraulic conductivity was calculated. The results are shown in Table D2.
