PLAYGROUND INSPECTION REPORT

Site Location Address: Bryanston School Park - 15237 Thirteen Mile Rd, Bryanston, Ontario, N0M 2A0

Report: Annual comprehensive

Date: March 25th, 2025

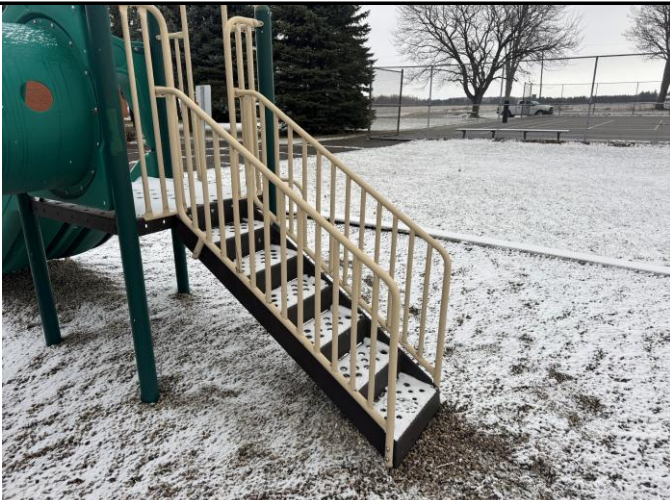
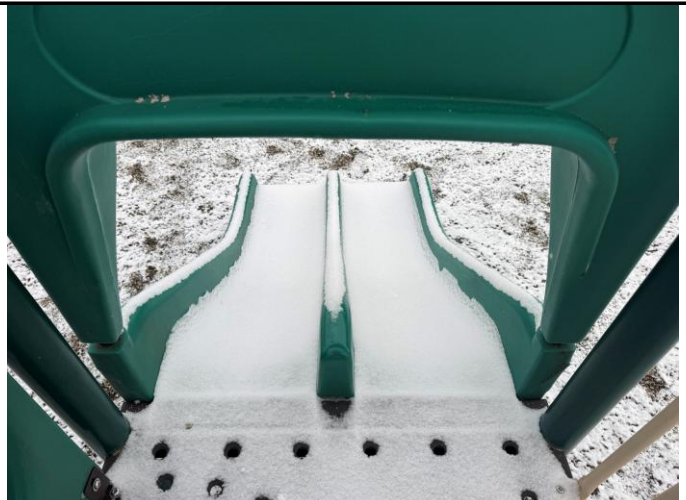
Playstructure

PLATFORM HEIGHT	CONDITION
1 x stairs closed	0cm - 95cm	Compliant
1 x switchback climber	95cm	Compliant
1 x dual slide	95cm	Non-compliant

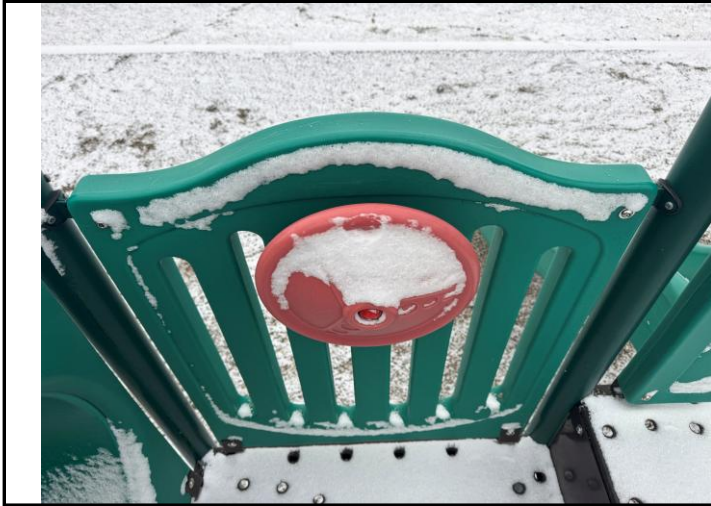
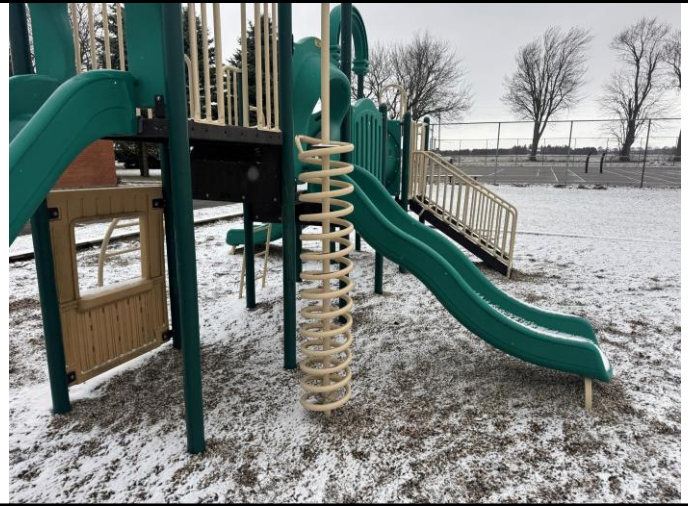
Playstructure	PLATFORM HEIGHT	CONDITION
1 x crawl tunnel	95cm - 95cm	Compliant
1 x steering wheel	95cm	Compliant
1 x rung ladder	95cm	Non-compliant
1 x arch rung climber	130cm	Non-compliant
1 x wave slide	130cm	Compliant
1 x access component	130cm - 175cm	Compliant
1 x corkscrew climber	175cm	Compliant
1 x wave slide	175cm	Compliant
1 x counter top panel	Ground level	Non-compliant

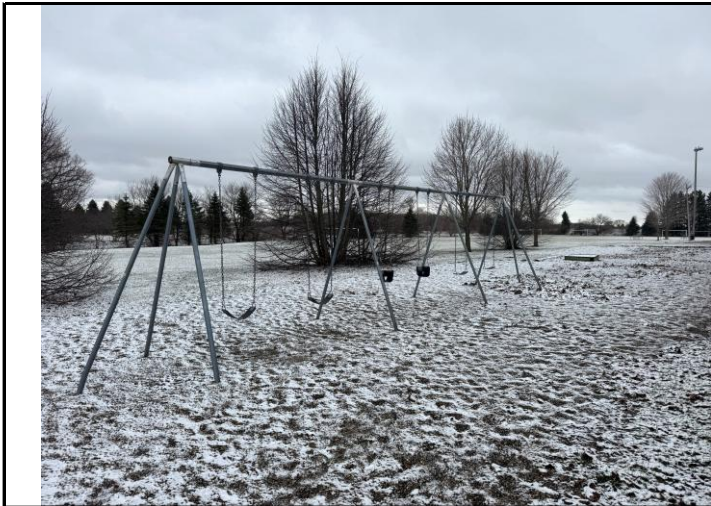
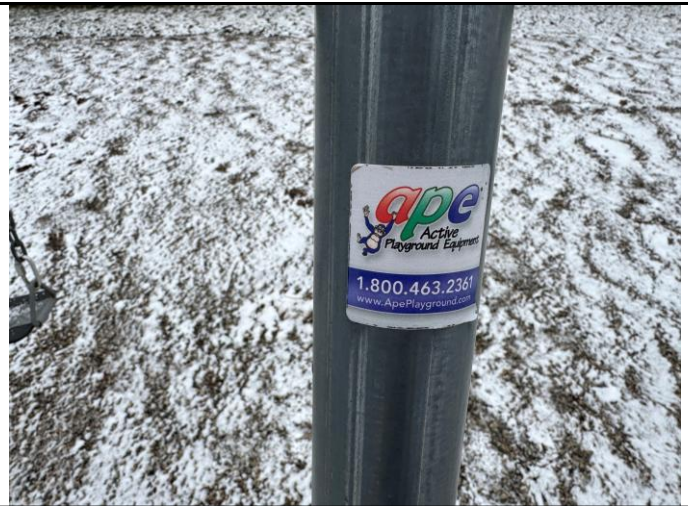
Swing set	MEASUREMENTS	CONDITION
1 x 3-leg 3-bay swing set - 4 x belt, 2 x tot	PP = 270cm	Compliant
	Y = 220cm
