**Potential Removal of the Coldstream Dam
St. Clair Region Conservation Authority**

21-118

January, 2024

GSS Engineering Consultants Ltd.

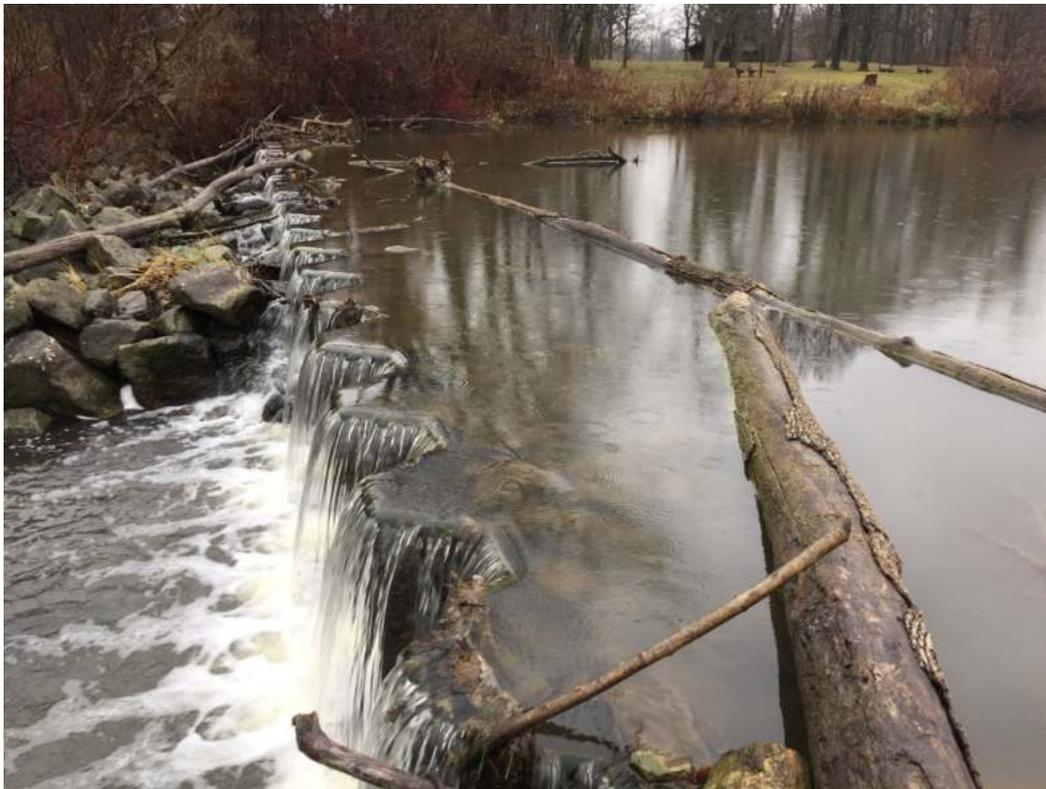
As noted previously, the dam is approximately 3.35 m high (normal upstream water level compared to normal downstream water level). The dam consists of vertical steel sheet piles driven into the riverbed below, forming a continuous retaining wall. The piles are made of heavy gauge ARCH-Type individual metal sheets locked together at the joints during installation. Original drawings for the dam show the sheets are driven into the soil below for a similar depth as the height of the sheets above the downstream water level.

Photo 1: Coldstream dam constructed of vertical sheet piling and downstream armour stone.

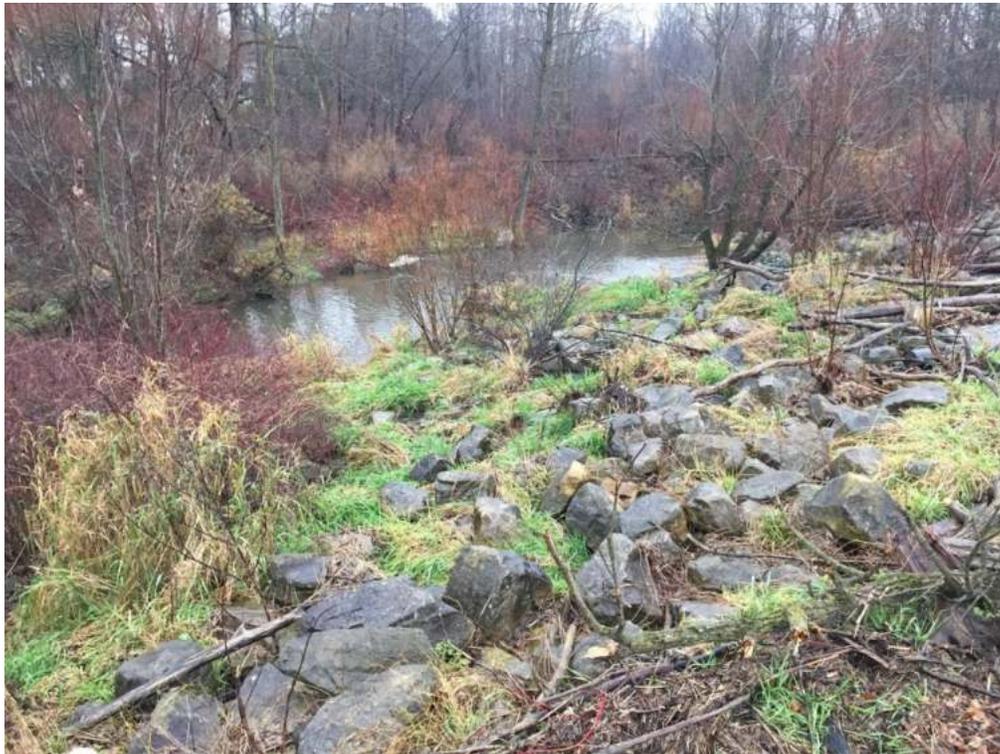
The downstream side of the sheet piling is protected by large armour stone (ranging in size from 16 inches to 24 inches in diameter) on a slope of approximately 3:1 horizontal to vertical. The armour stone provides protection to the soil material below the sheet pile wall from erosion. The sheet pile portion of the dam is approximately 45 m wide. The adjacent earthen berm portion of the dam (south of sheet pile dam portion) is approximately 40 m long.

Photo 2: Large sloping armour stone placement on downstream side of sheet pile dam. Sydenham River downstream of dam visible in background.

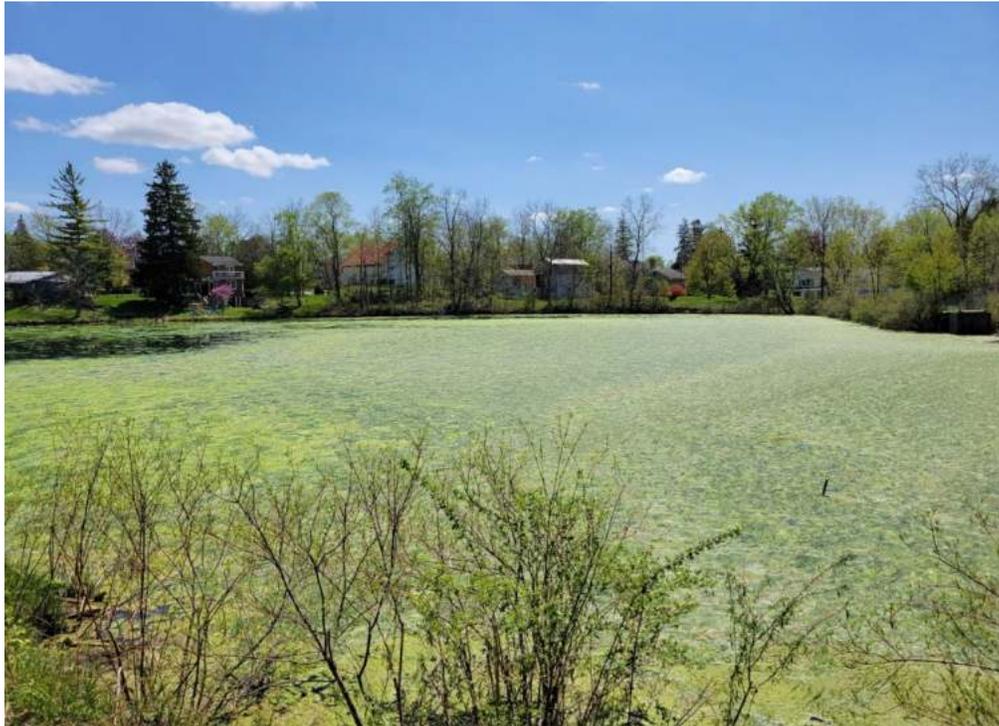
Photo 3: Algal bloom in the Coldstream dam head pond in May 2022. View to the southwest to the dam area from the Coldstream Conservation Area on the northwest shore. (SCRCA photo.)

The following photos (**Photo 3** and **Photo 4**) depict unusually heavy algae blooms in the Coldstream dam head pond in May, 2022.

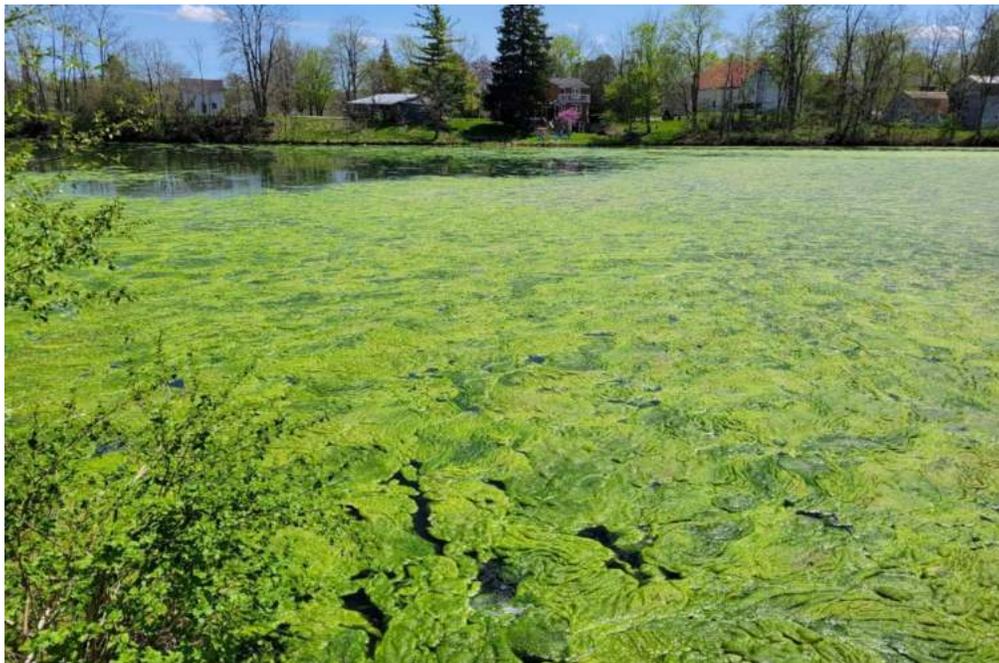
Photo 4: Algal bloom in the Coldstream dam head pond in May 2022. View to the east toward Ilderton Road from the Coldstream Conservation Area on the northwest shore. (SCRCA photo.)

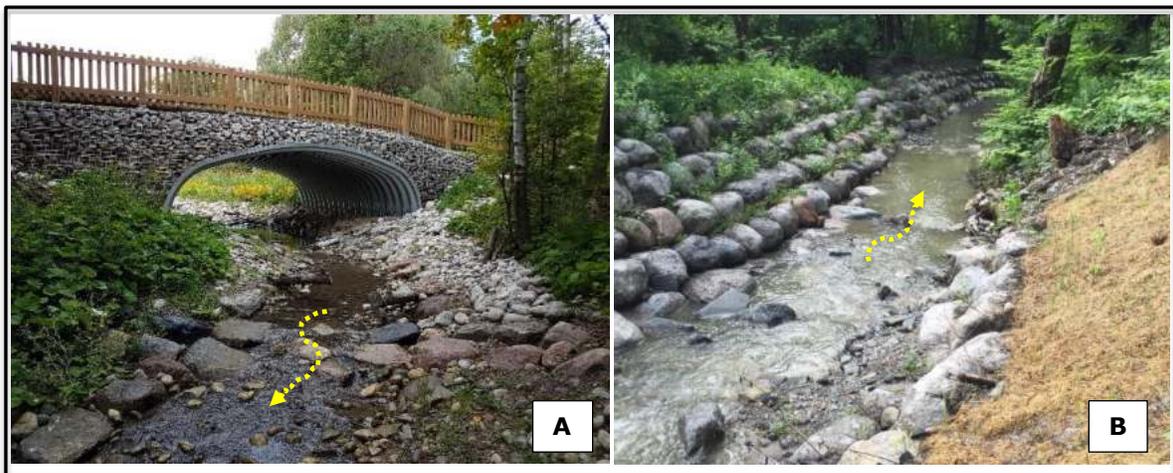
Figure 1: A) Typical vortex rock weir

B) Typical vegetated rock buttress

Example photographs of constructed channel bioengineering techniques are included in **Figure 1**.

Example photographs of constructed channel bed grade controls and bank bioengineering techniques are included in **Figure 1**. **Figure 1A** displays a weir grade control supported by brush matting along the channel banks. The toe of the brush mattress treatment is reinforced with stone, for stability, while the upper banks gradually revegetate. In **Figure 1B**, the left bank is reinforced with a vegetative rock buttress to combat lateral migration. In addition, the bed is reinforced with hydraulically-sized stone weirs to combat downcutting while maintaining flow connectivity (and fish passage) through the restored reach. This represents a more robust design alternative applicable in areas where the erosion potential is high.

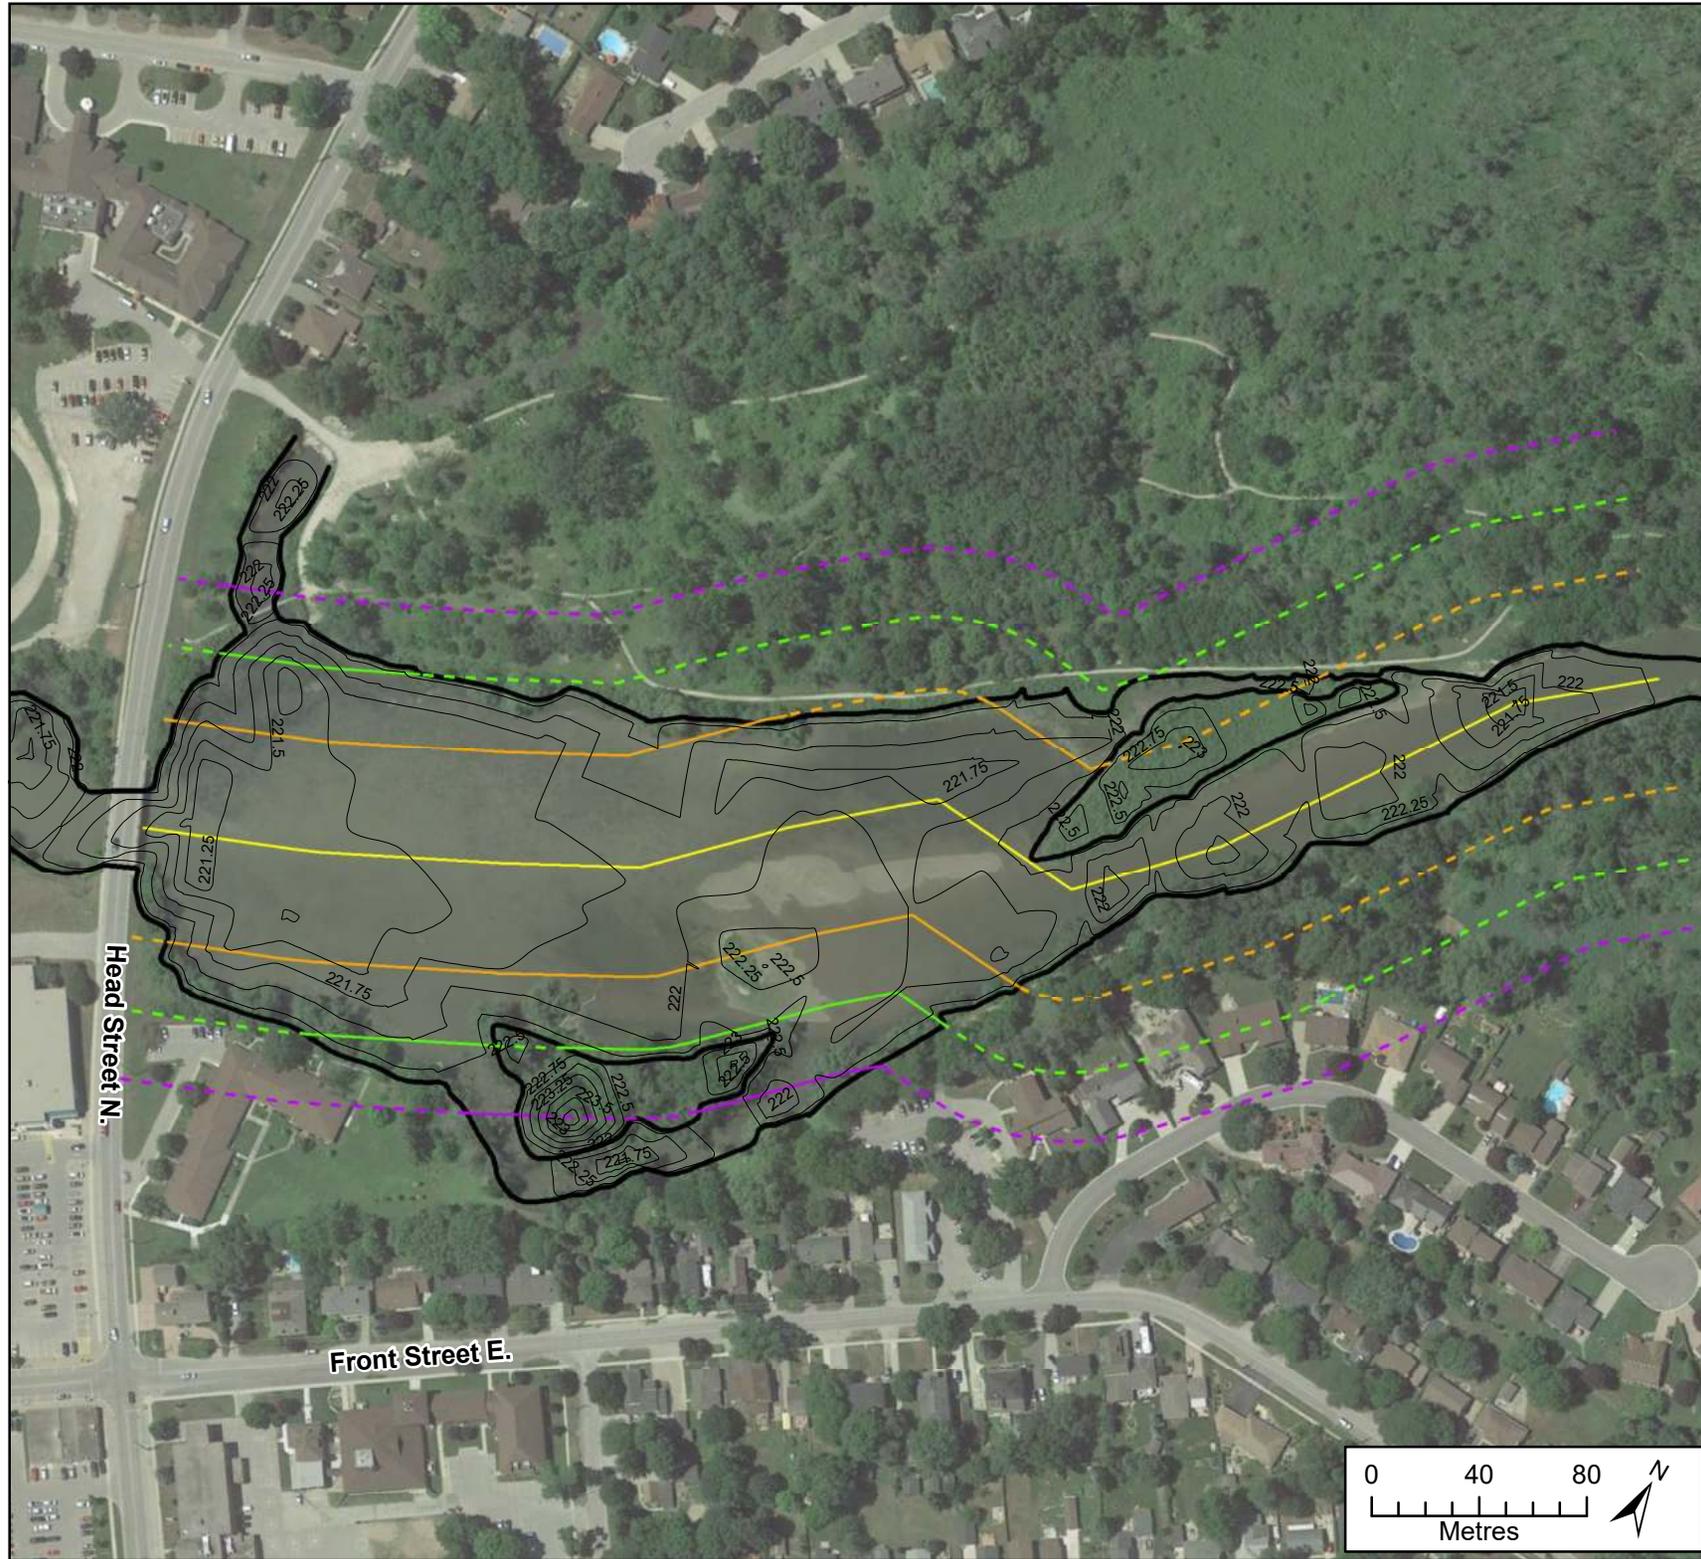
Preliminary MBW
Based on Historical Thalweg
Head Street Reservoir
Strathroy, Ontario

Corresponding dashed lines represent outside of approximate top of bank

We have reviewed the cross-sections, and the boundary of the reservoir generally appear to correspond with the top of bank
