## Subsurface Assessment

Proposed Residential Development  
10283 Ilderton Road  
Coldstream, Ontario

LON-00017783-GE

Geotechnical Report

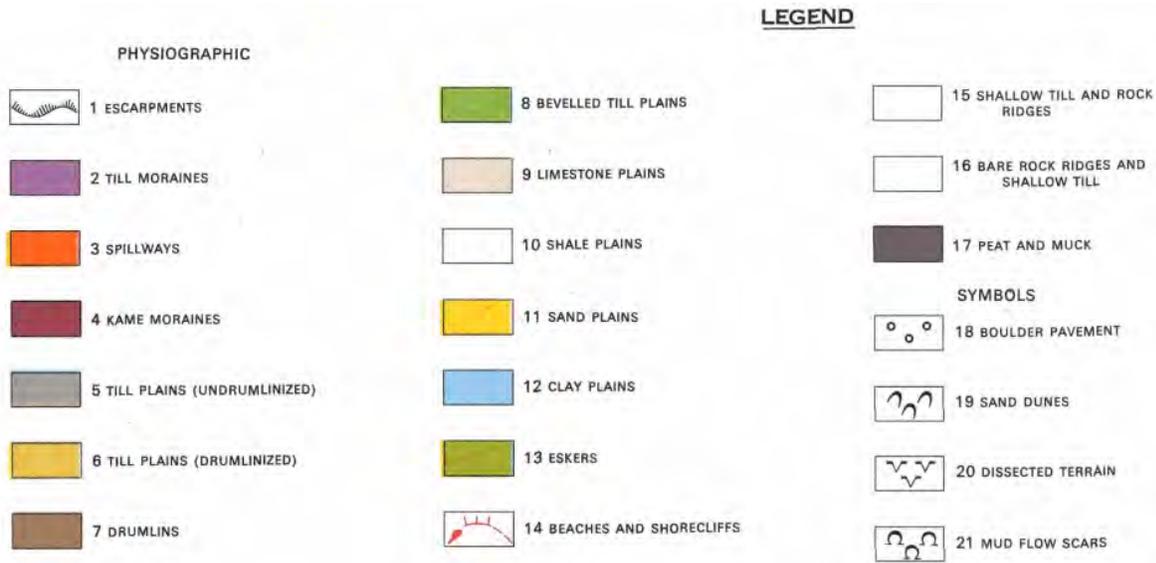
The surficial deposits were mapped and categorized into a number of physiographic regions by Chapman and Putnam (1984). The physiographic regional mapping for the area (indicates that the site is situated within the Caradoc Sand Plains and London Annex (Chapman and Putnam, 1984).

Review of physiographic landform mapping, above, indicates that the Site is located within sand plains. Quaternary geology mapping indicates the Site is located in an area characterized by Rannoch Till: generally a silt to clayey silt matrix becoming finer grained southward.

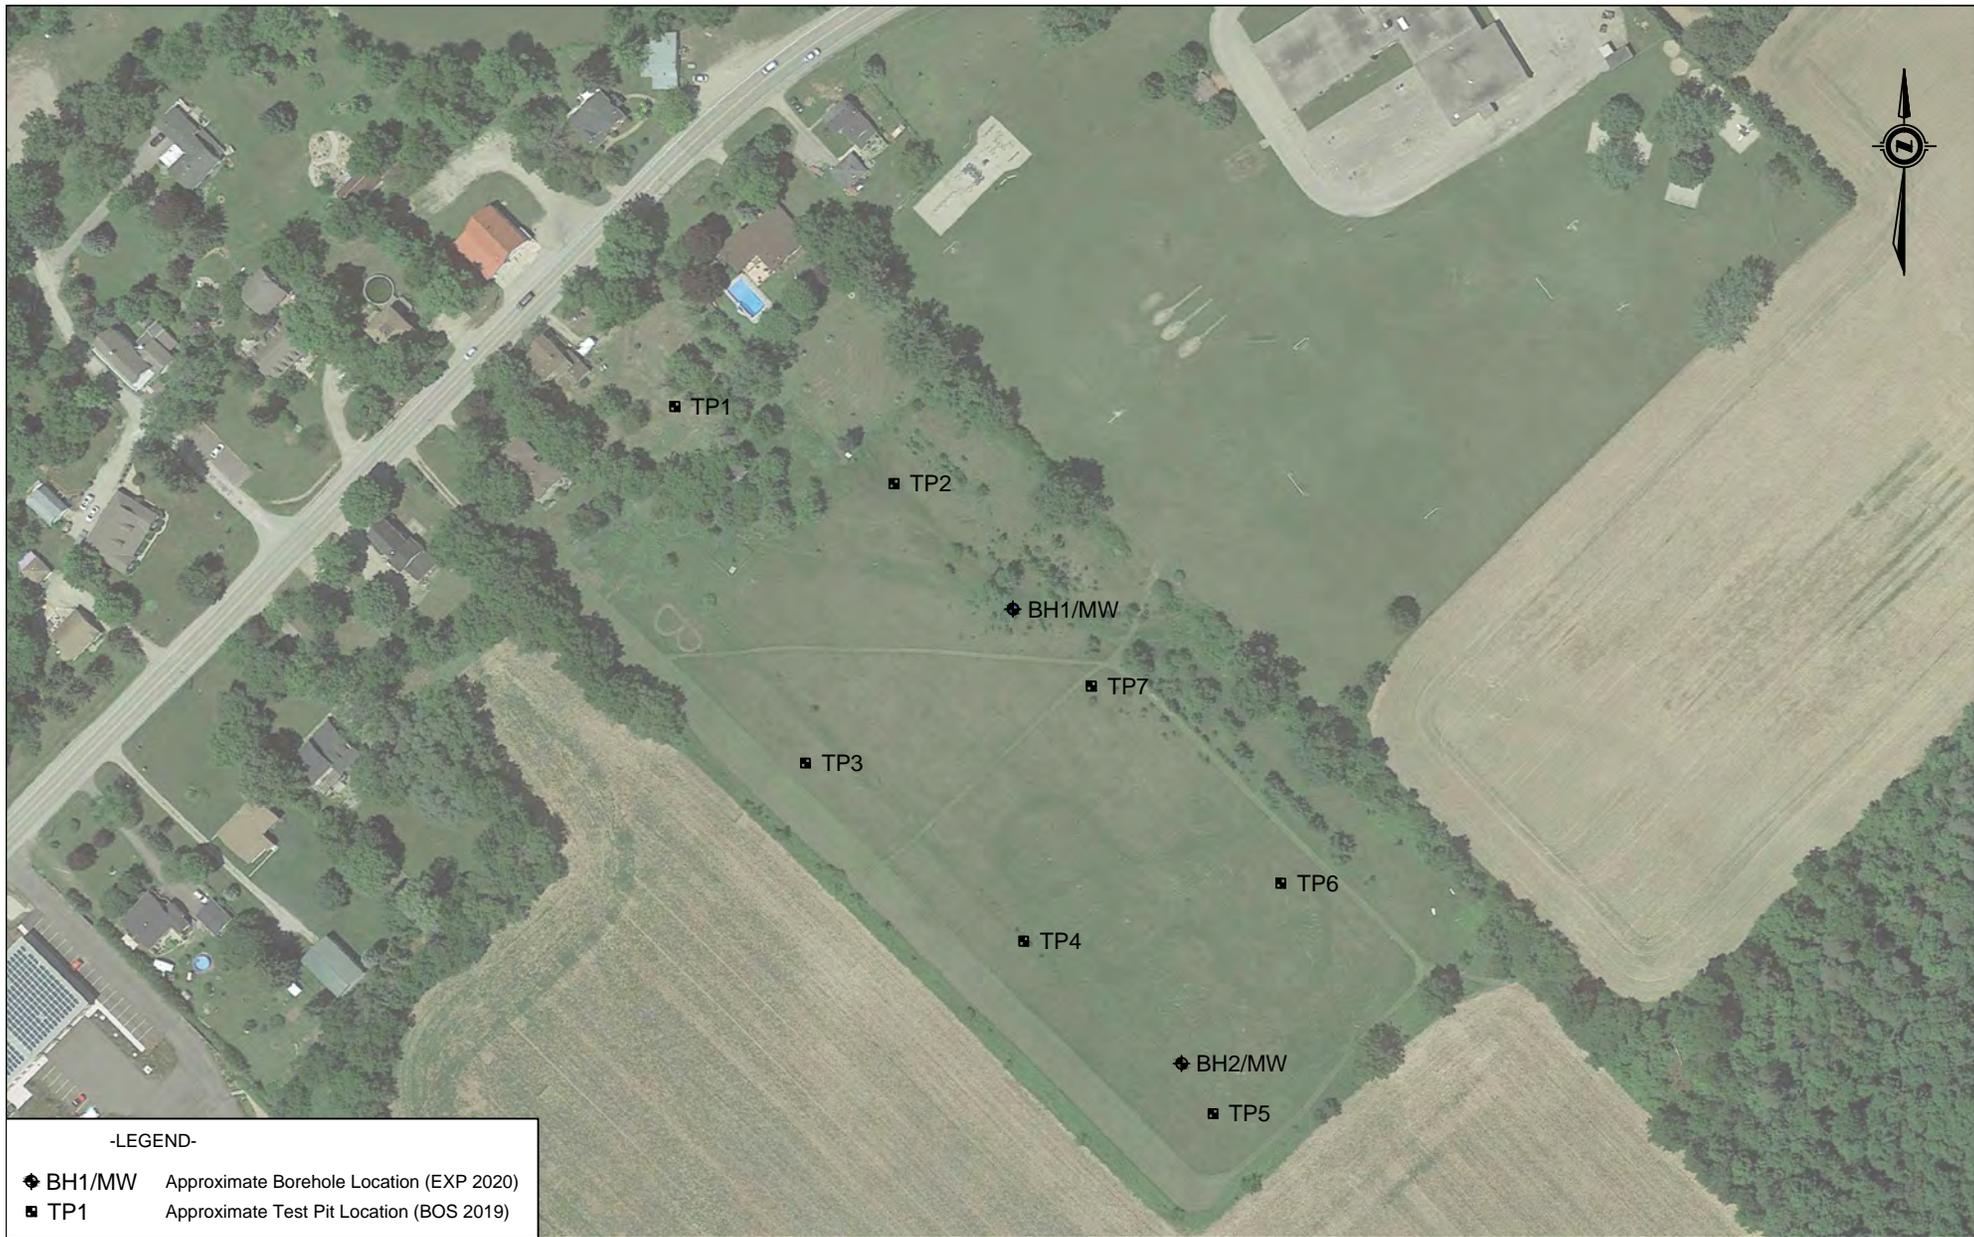
- ◆ BH1/MW Approximate Borehole Location (EXP 2020)
- TP1 Approximate Test Pit Location (BOS 2019)
