# Municipality of Middlesex Centre Komoka Drainage Works, Union Avenue Branch Council Update

March 10, 2021

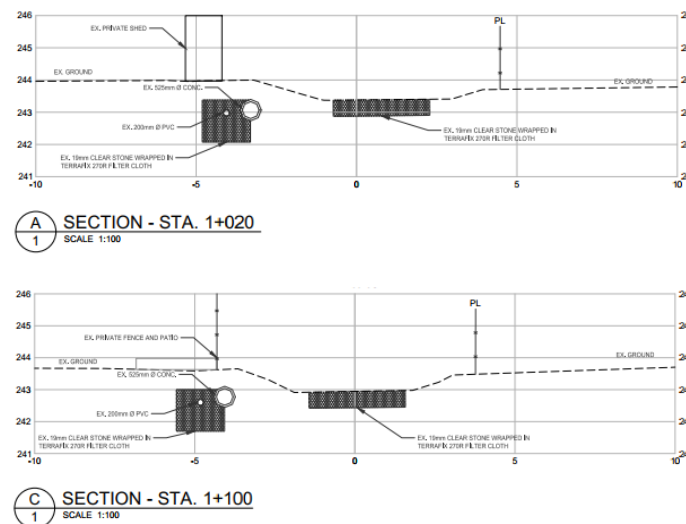
- Open ditch
- 525mm – 750mm Ø concrete pipe + 200mm PVC pipe + infiltration gallery
- Latest 2007 Engineer's Report states the system was designed to accommodate the 100-year storm flows through a combined low flow pipe and swale

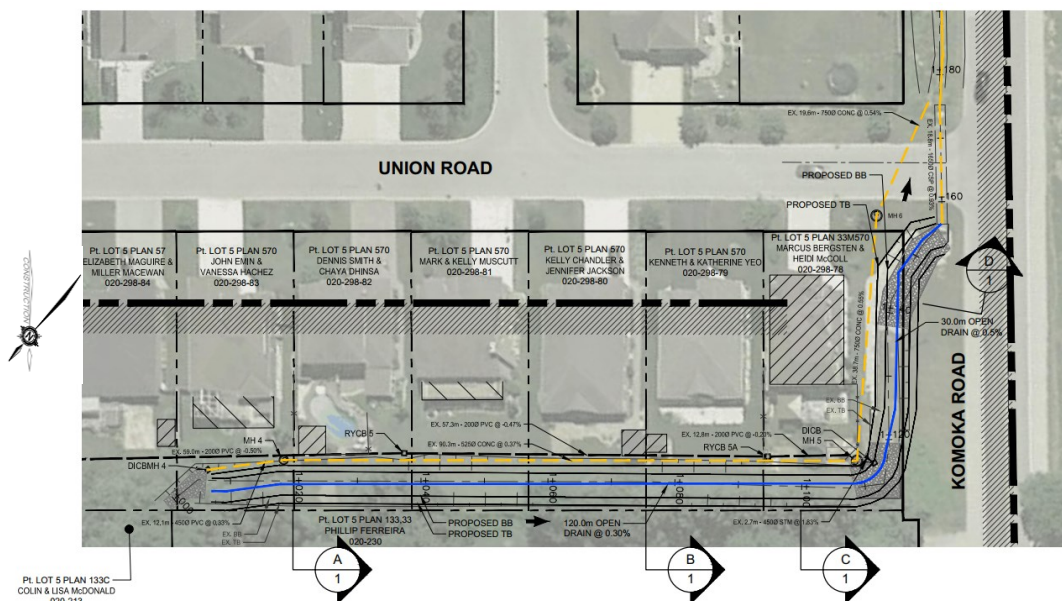
- Widening and deepening the existing swale
- No work on the existing closed system (maintained)
- Erosion control additions
- Property restoration
